35254 - Aura Court, 1 Percy Street, Manchester, Greater  
Manchester, M15 4AB

**Fire Risk Appraisal of the External Wall (FRAEW)**

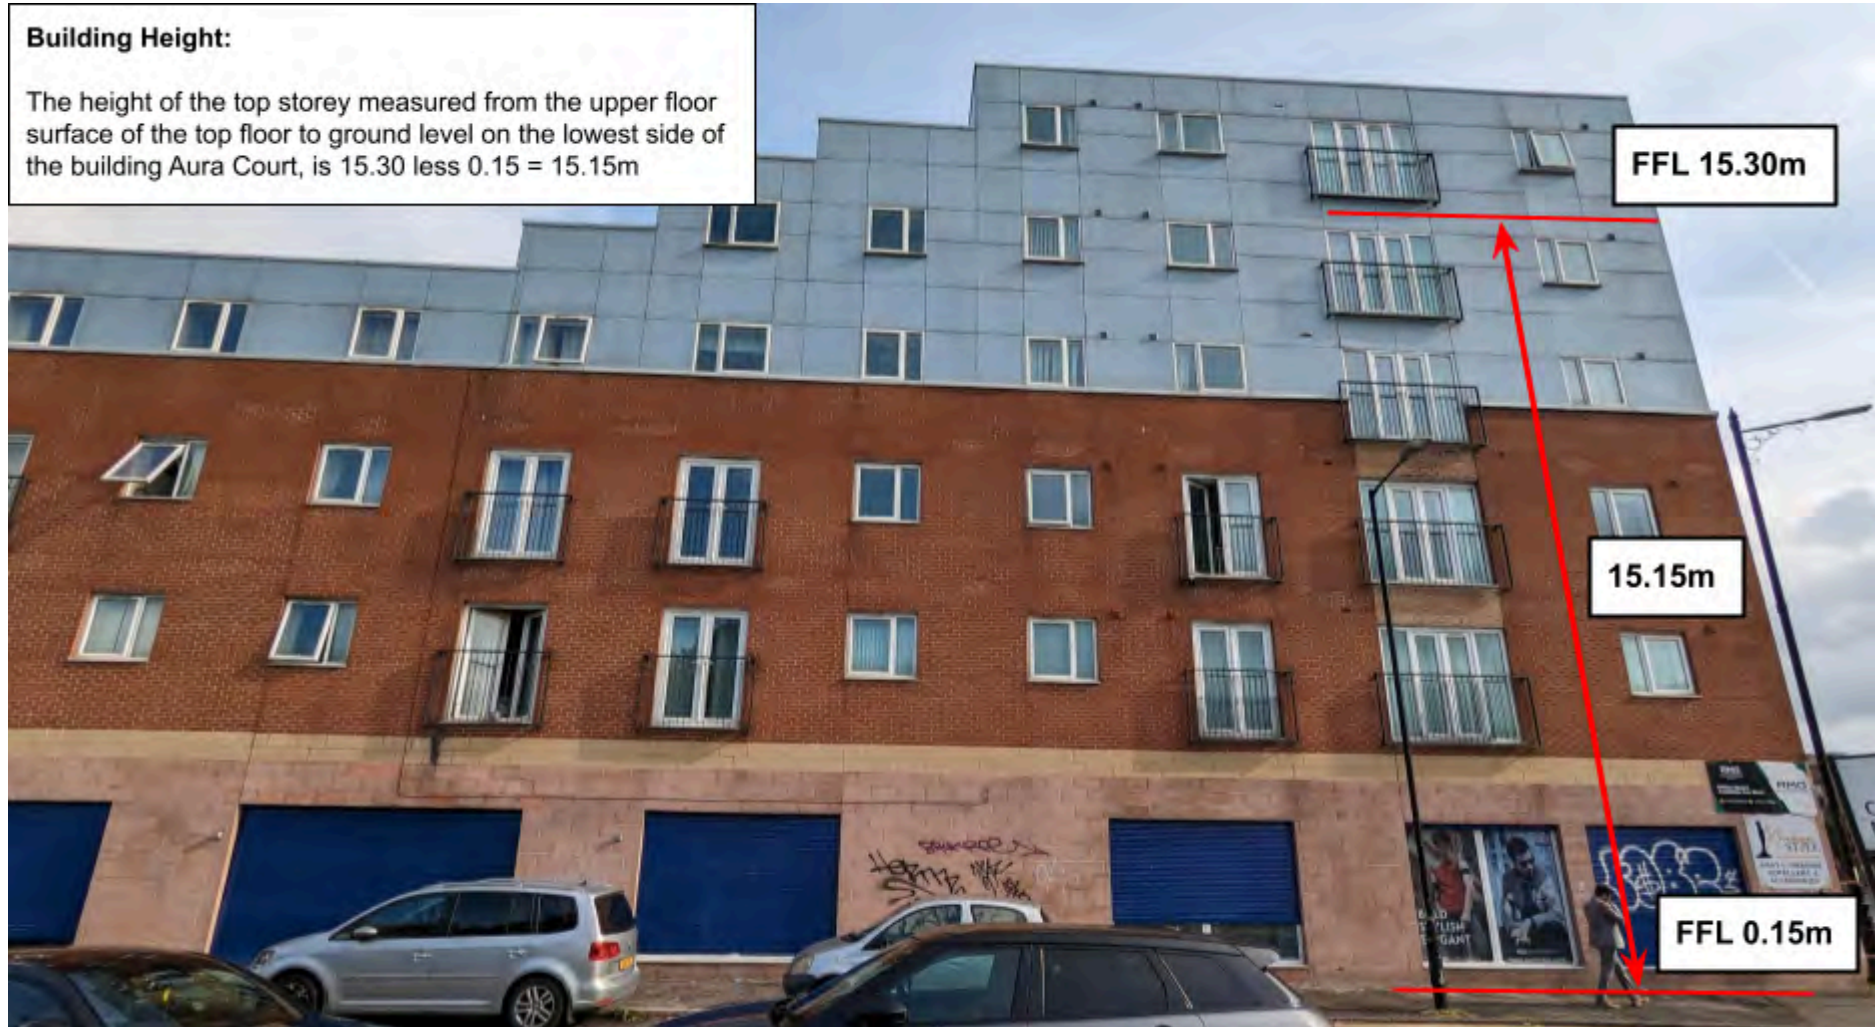
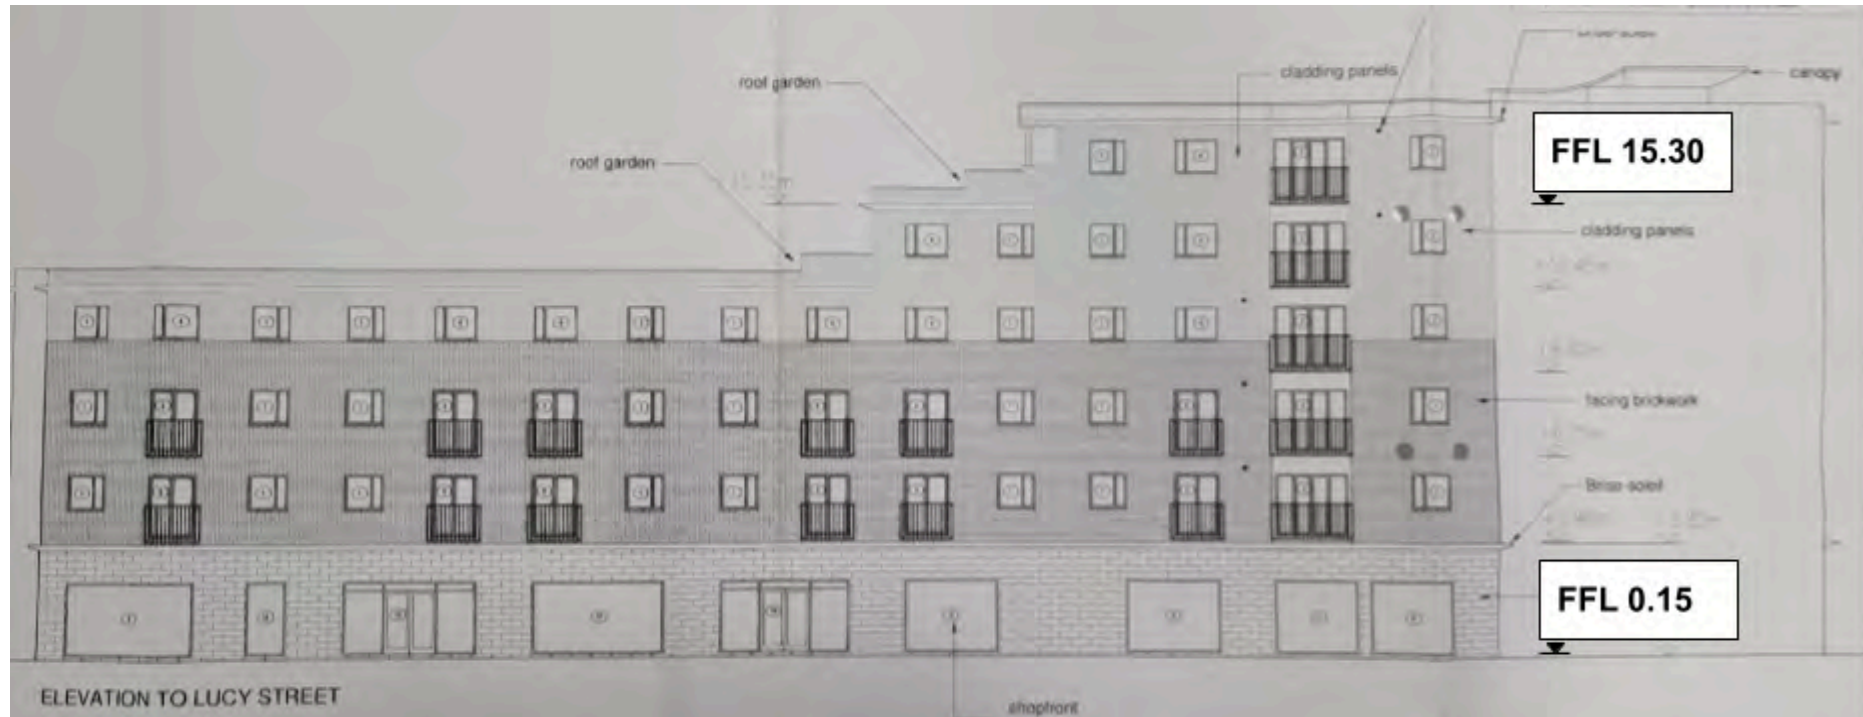
Diagram Showing the height of the Building on Lucy Street facing South West taken from Drawing Number: (2-) 08

**Height Calculation: 15.30 less 0.15 FFL = 15.15m**

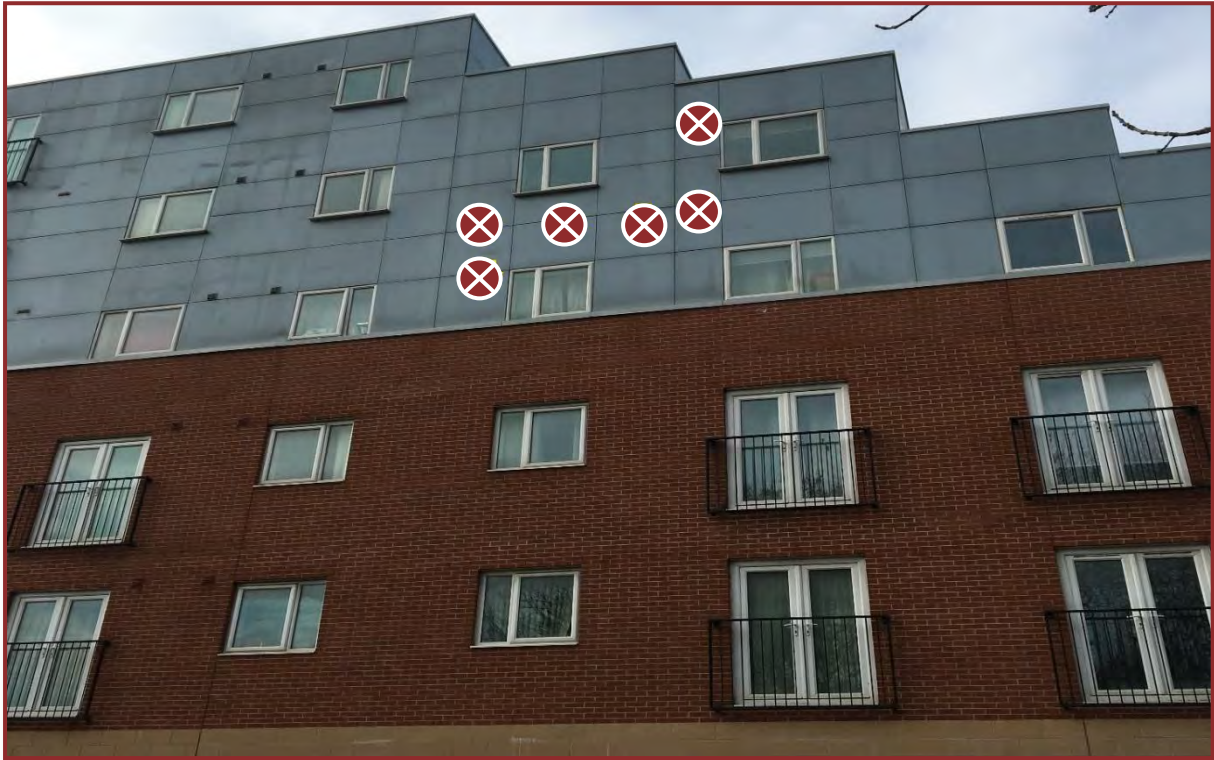
Image of Trespa Meteon HPL sample taken during survey. Made of compacted wood/paper and resin, the majority of HPL products have the potential to be extremely combustible.

**Area One:** We would recommend that the entirety of the HPL material used in the upper level cladding of all elevations **be replaced** with a suitable alternative with a product of limited or no combustibility. The product used has been identified as 8mm Trespa Meteon, a panel with a Euroclass D fire rating. For comparison, the Aluminium Composite Material (ACM) used in the cladding of Grenfell was Euroclass B rated.

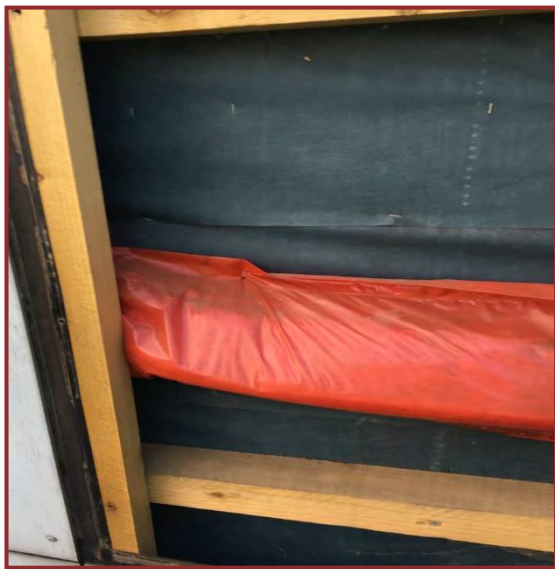
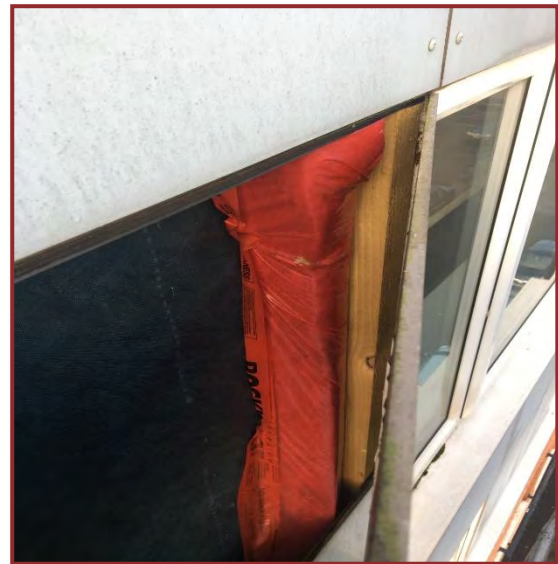
Images showing the horizontal and vertical Rockwool 'sock' fire barriers. Their fitting, which doesn't cover the entire cavity, means that they will not be able to perform their task effectively.

Although fire barriers were present behind the Trespa cladding, these **were not** fitted in a way that would provide effective fire stopping protection and we would recommend that they be **reviewed and replaced** in a manner that would delay the spread of a fire.

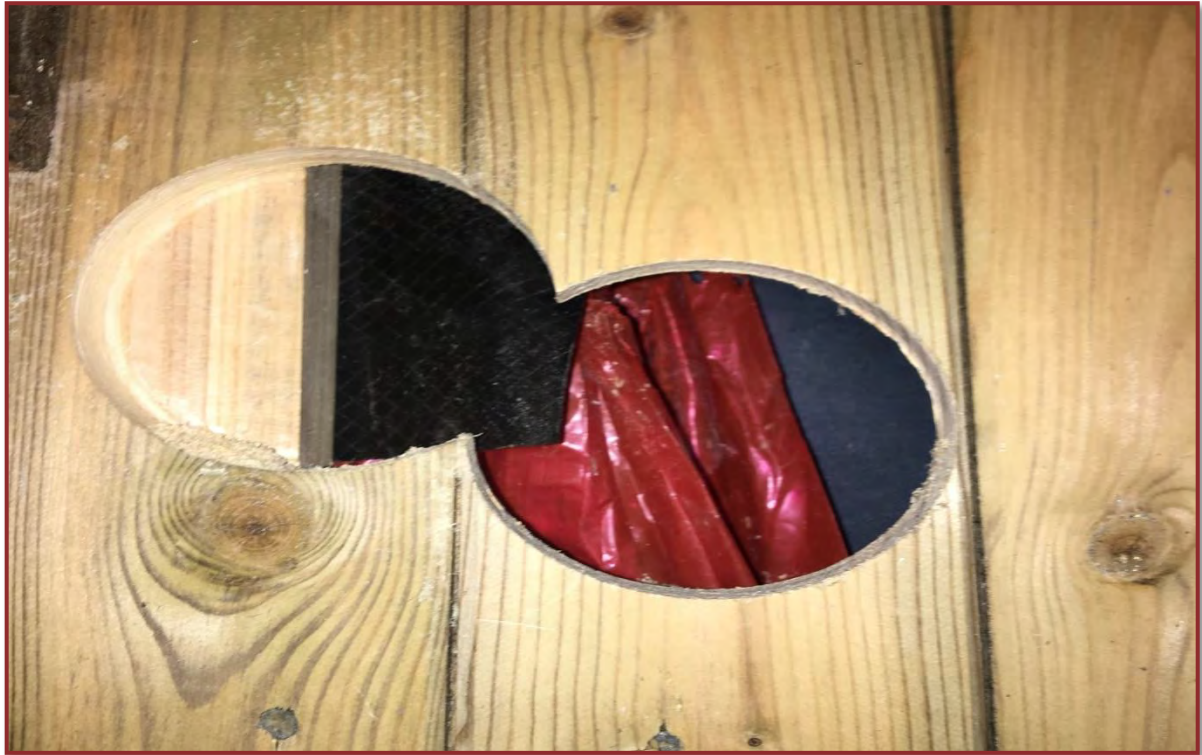
Close-up of the Rockwool 'sock' cavity closer along with the timber support batten, no insulation can be seen in the cavity. The timber cladding does not appear to have been treated with any fire-resistant products during manufacture.

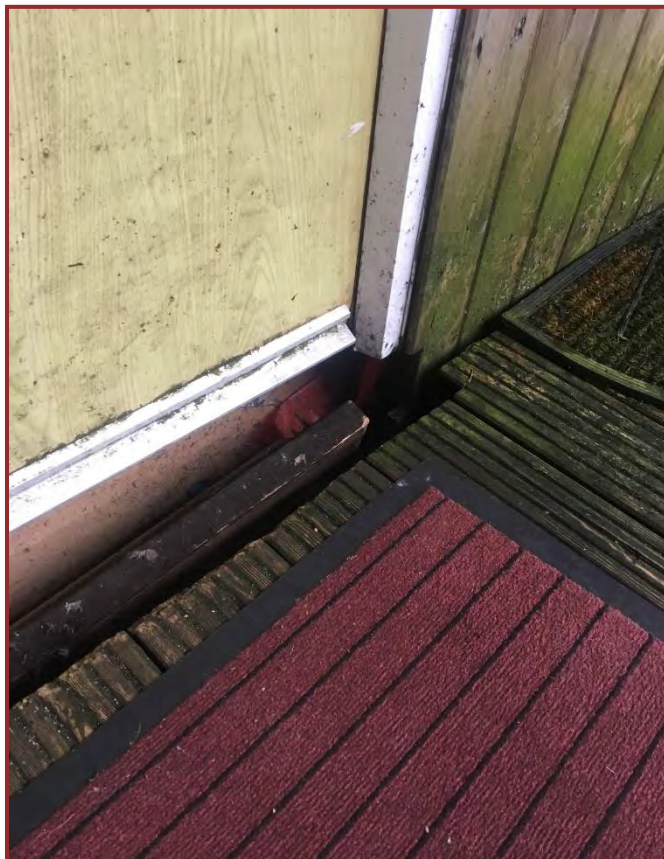
There is a lack of fire barriers at the floor slab under the door frame as shown here. There is a clear continuation of the timber cladding from the floor below, which would assist the spread of any fire.

(Damage to door frame and cill was existing)

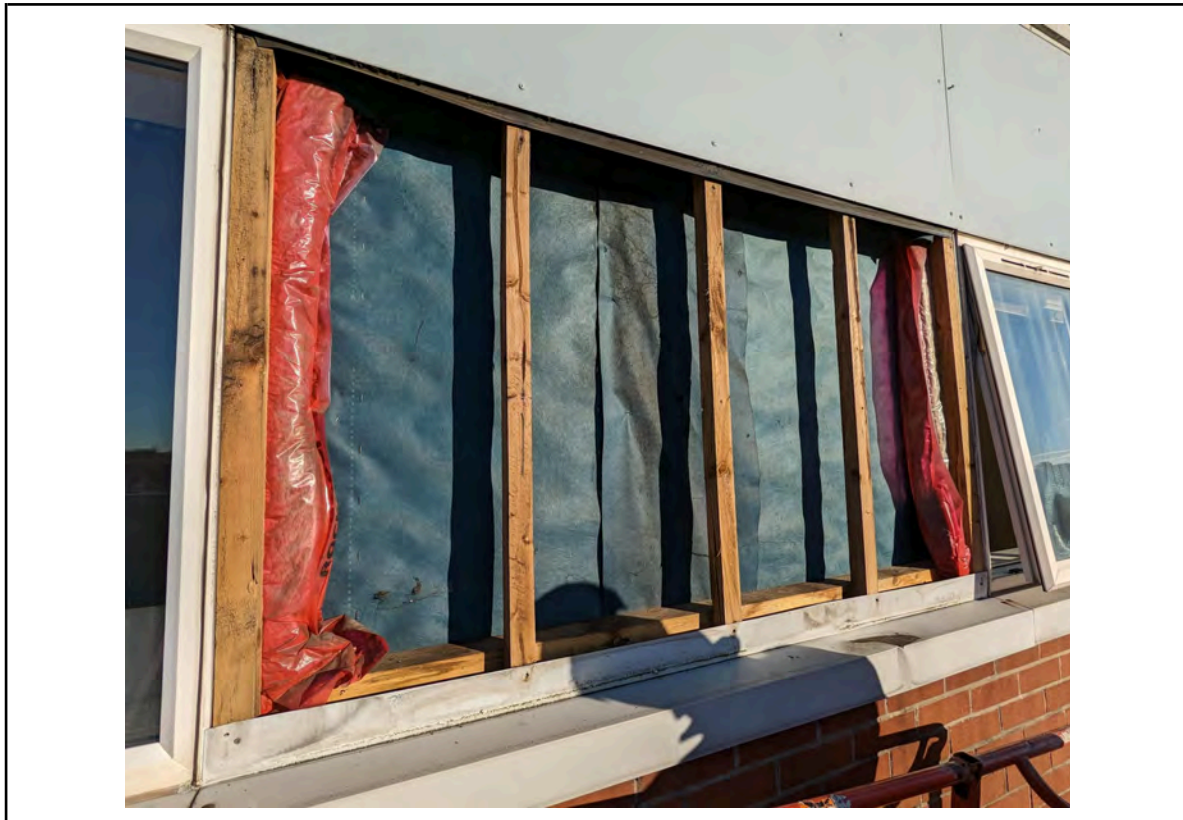
Photo 5: Location 1 - HPL removed on 3rd floor on 3rd floor at South West Elevation

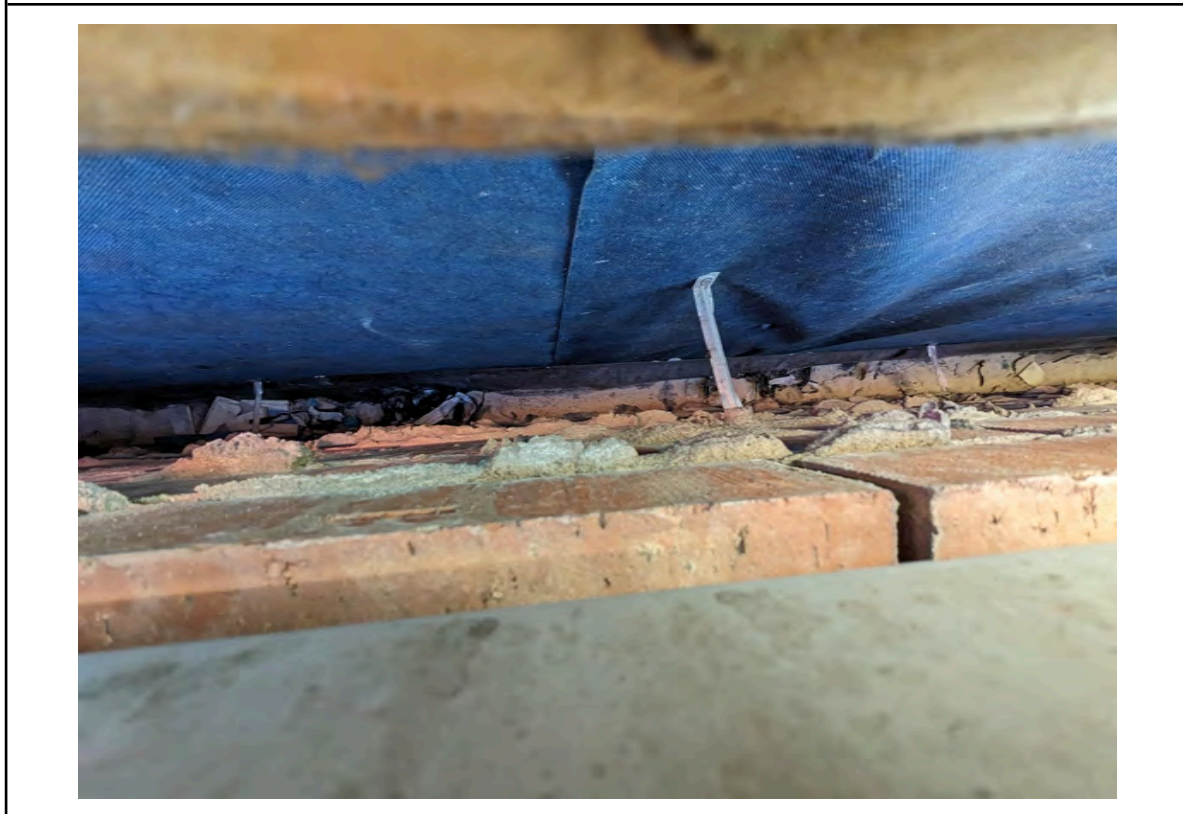
Photo 6: Location 1 - Cavity showing absence of horizontal barriers at compartment floors

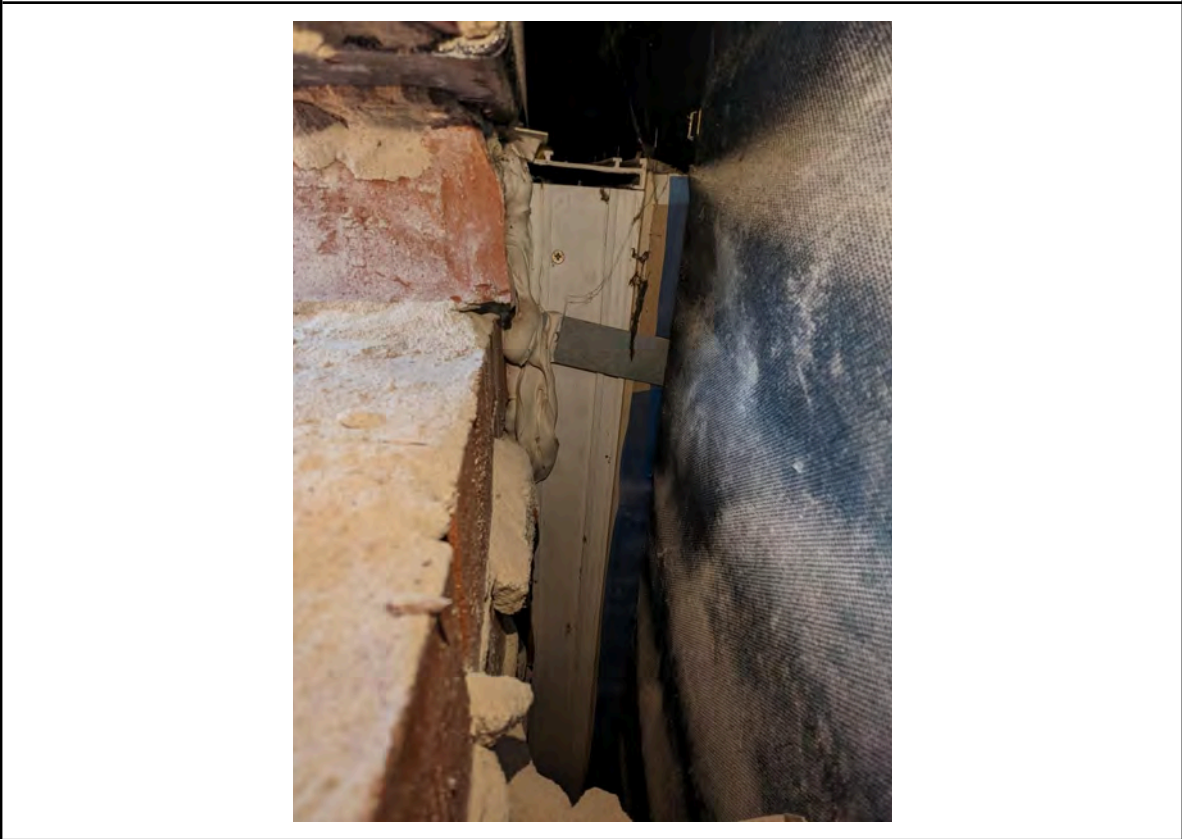
Photo 8: Location 2 - Cavity with wall ties and breather membrane, but no cavity closer at window opening

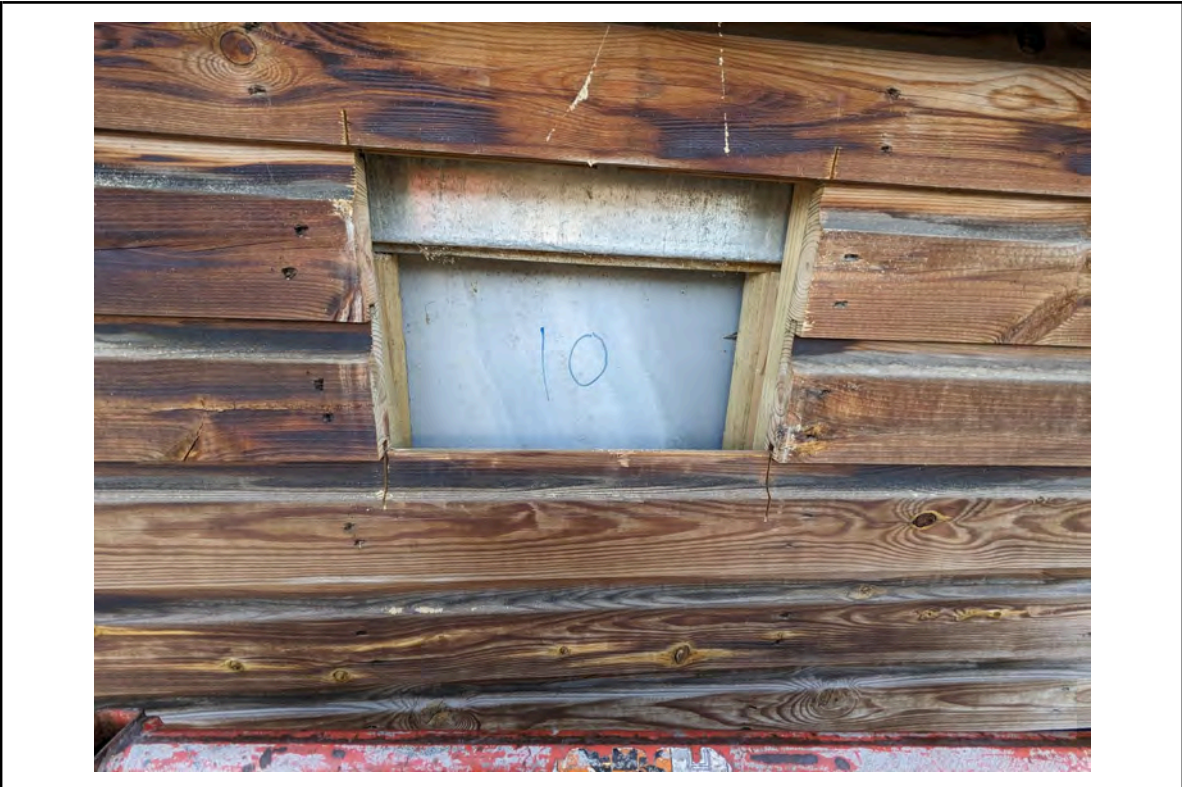
Photo 23: Location 10 - timber spandrel panel cored out on 1st floor balcony at business centre entrance

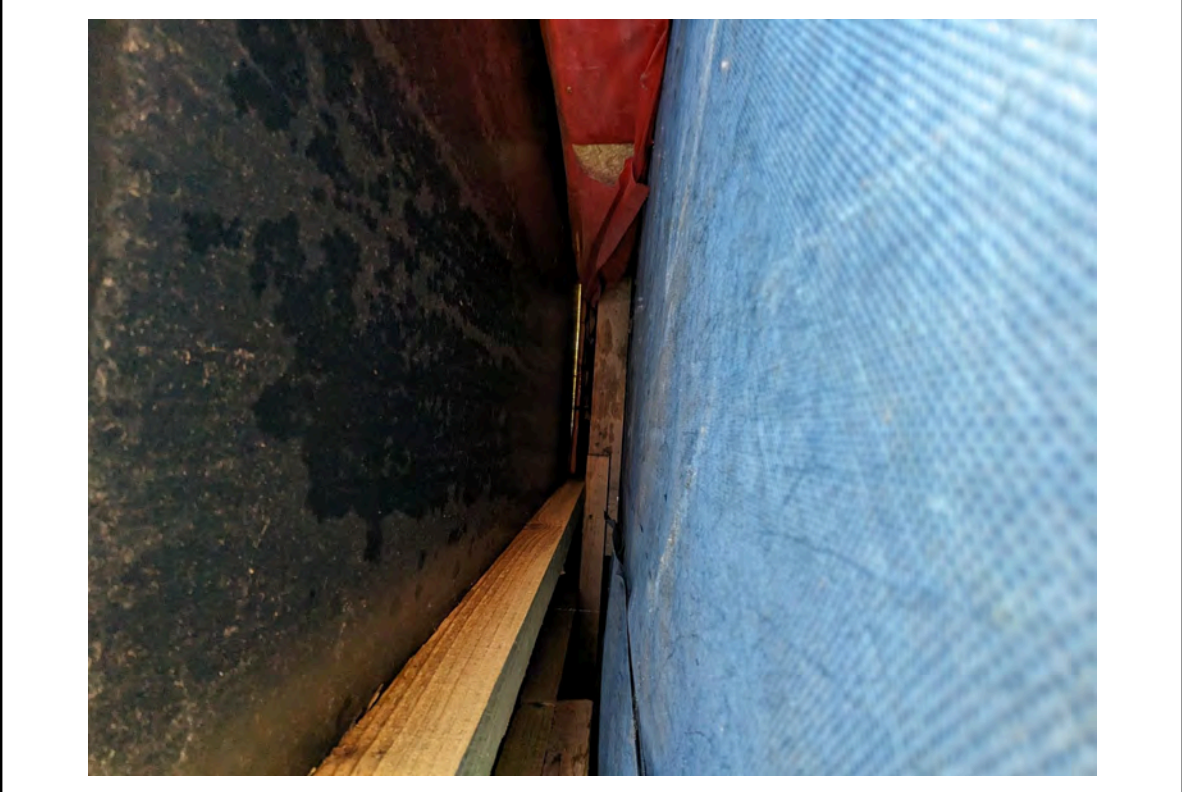
Photo 28: Location 12 - Cavity showing the timber studs, breather membrane and horizontal barriers, but no vertical barrier

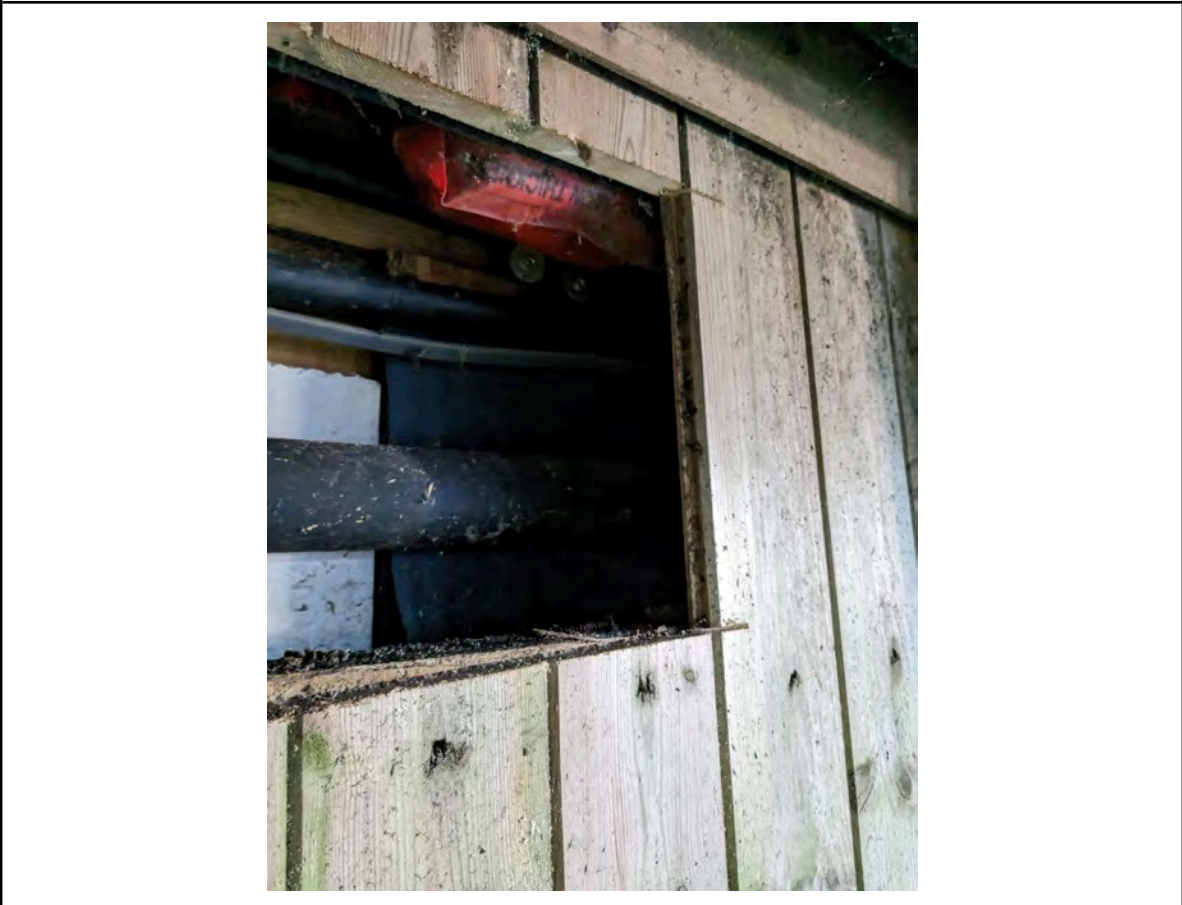
Photo 54: Location 25 - Cavity with barriers, thermoplastic insulations and breather membrane

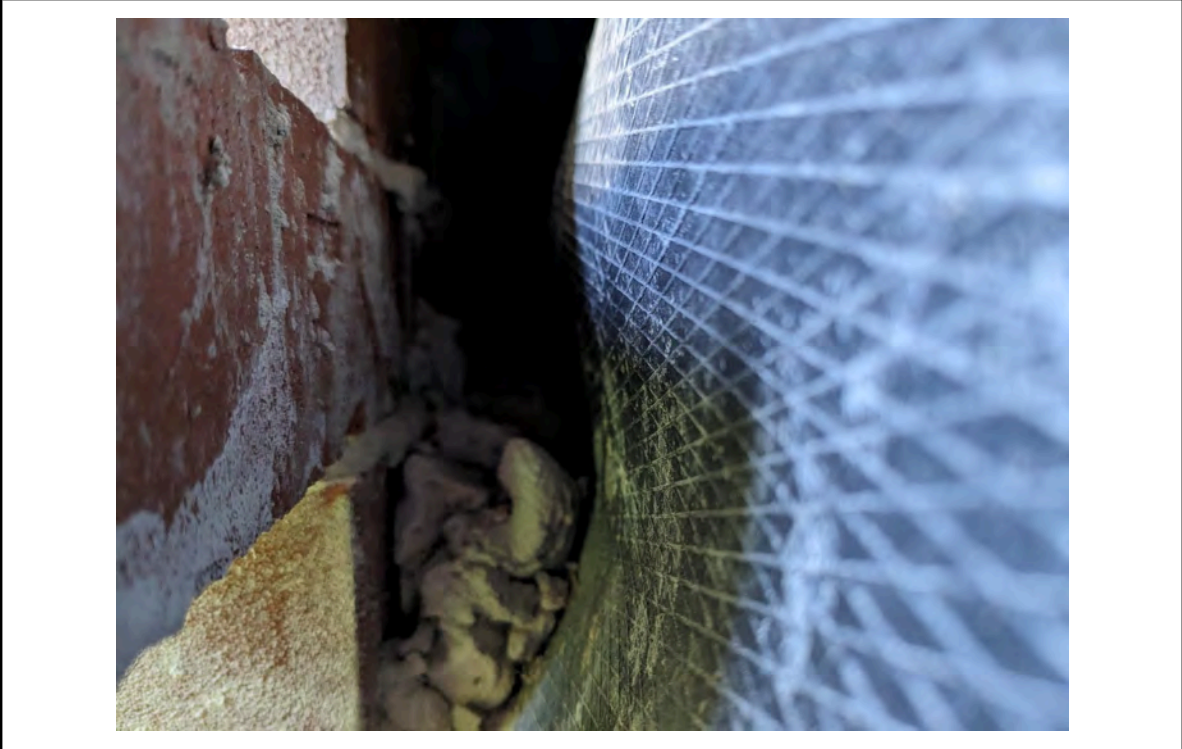
Photo 64: Location 29 - Cavity with no cavity barriers in line with compartment walls

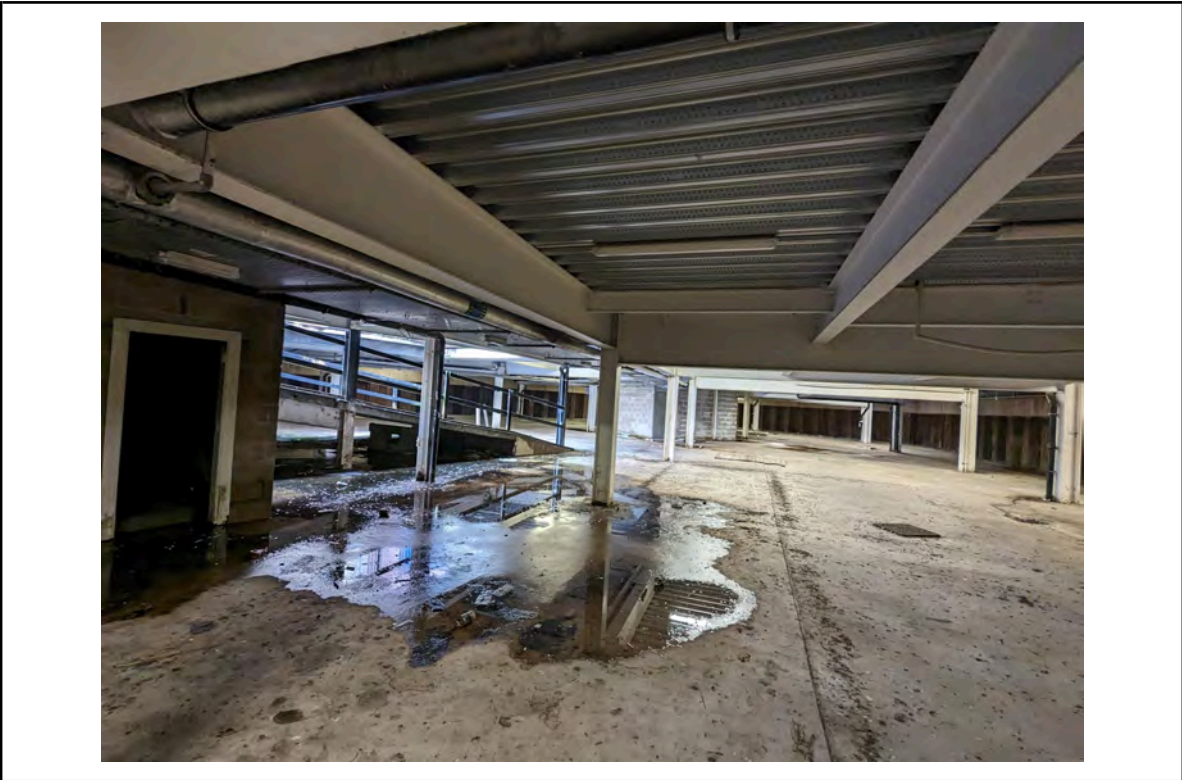
Photo 65: General view of basement car park with composite decking

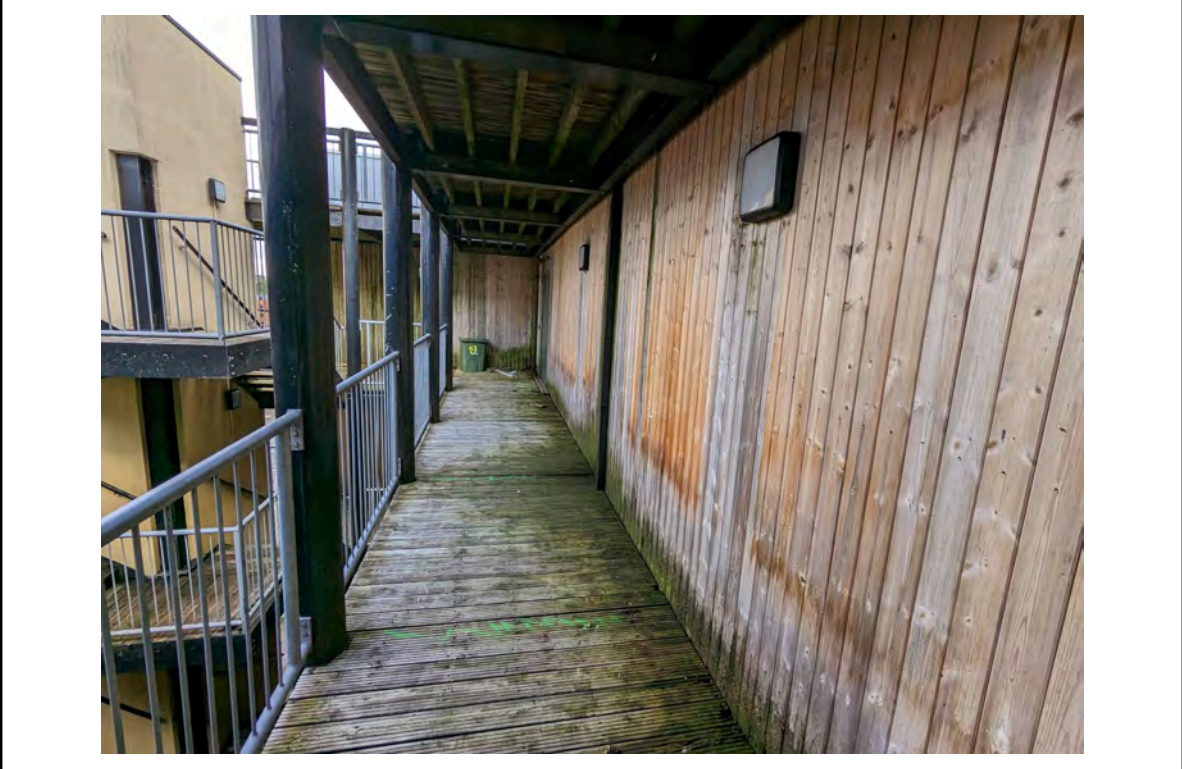
Photo 66: General view of exterior walkway at inner courtyard area

All of the walkways have been constructed with a timber decking. A link to a test video concerning timber decking used in balconies and walkways can be found below. This shows the importance of ensuring balcony areas are kept clear of barbeques and other sources of fire. Replacement of the timber cladding with a material of limited combustibility should be considered.
