35254 - Aura Court, 1 Percy Street, Manchester, Greater  
Manchester, M15 4AB

**Fire Risk Appraisal of the External Wall (FRAEW)**

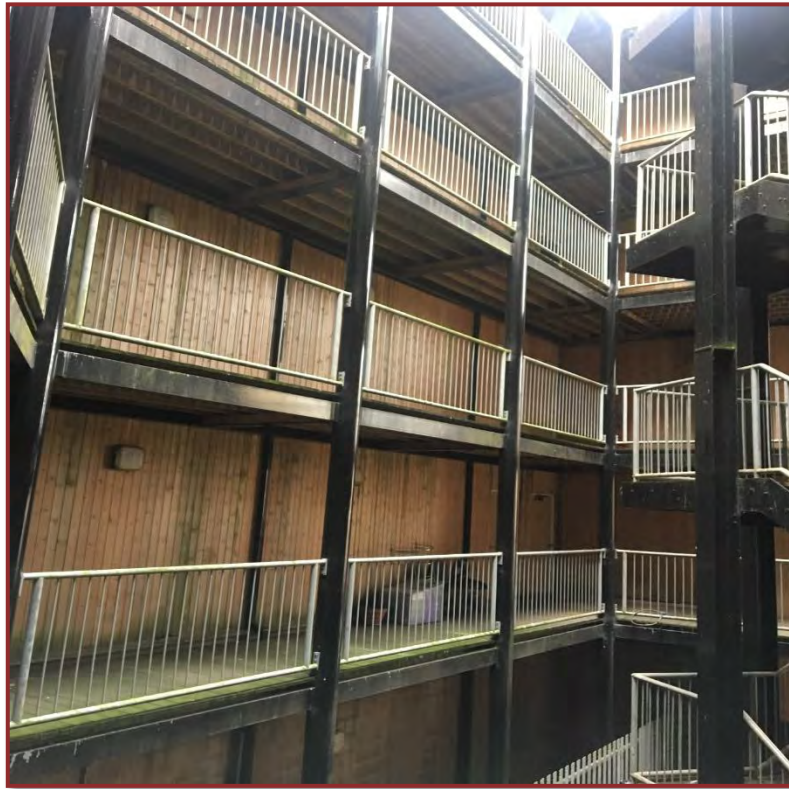
Inner courtyard area clad in timber with doors to each flat and a central staircase with access to the flats.

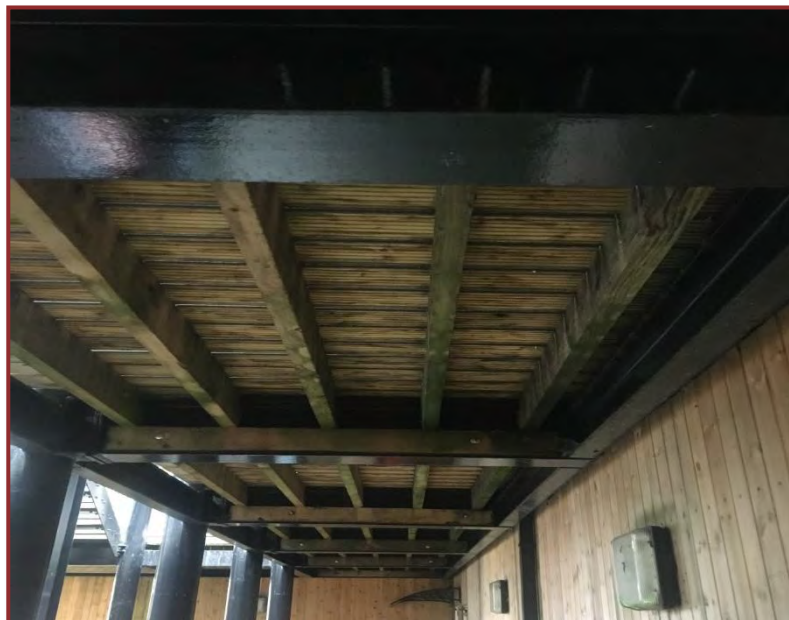
The timber decking of the walkways in the inner courtyard shown from below with softwood timber joists.

All of the walkways have been constructed with a timber decking. A link to a test video concerning timber decking used in balconies and walkways can be found below. This shows the importance of ensuring balcony areas are kept clear of barbeques and other sources of fire. Replacement of the timber cladding with a material of limited combustibility should be considered.

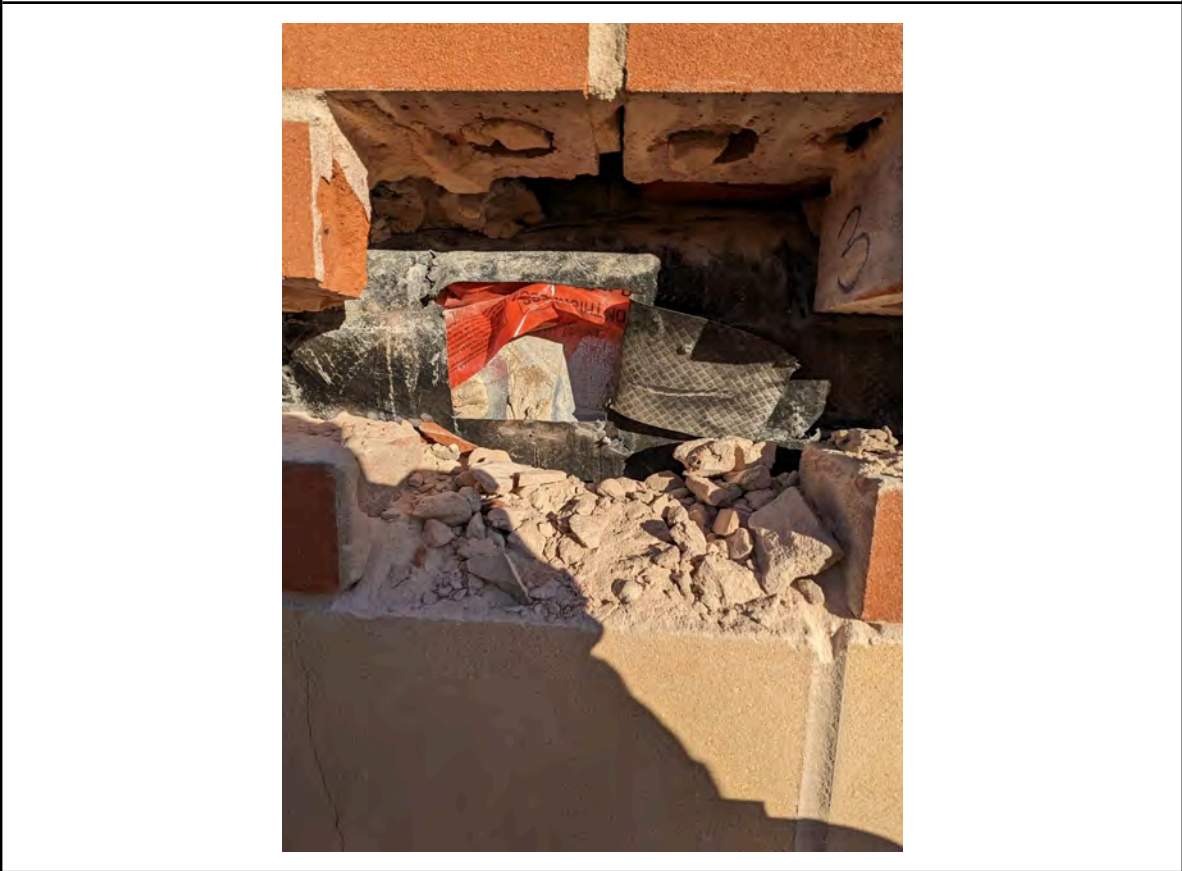
Photo 10: Location 3 - Cavity with wall ties, damp proof membrane and cavity barriers

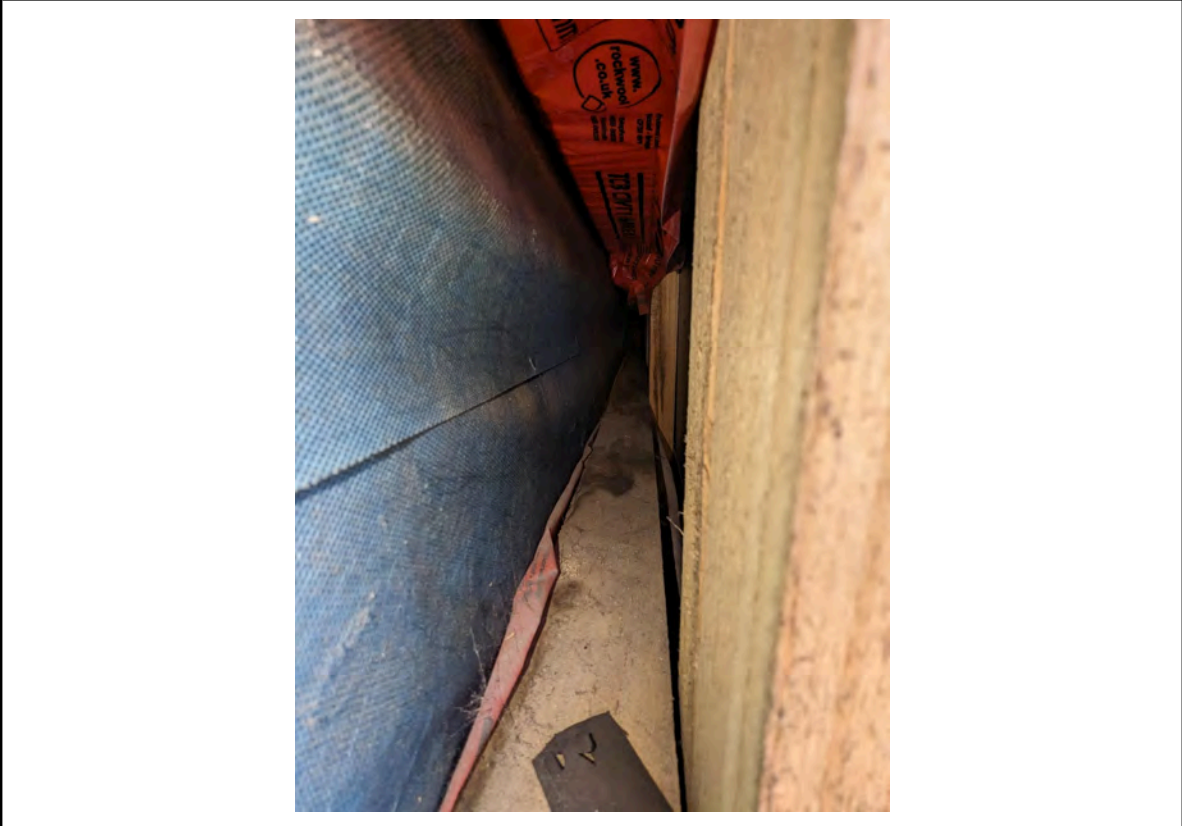
Photo 12: Location 4 - Cavity showing timber studs, breather membrane and cavity barriers

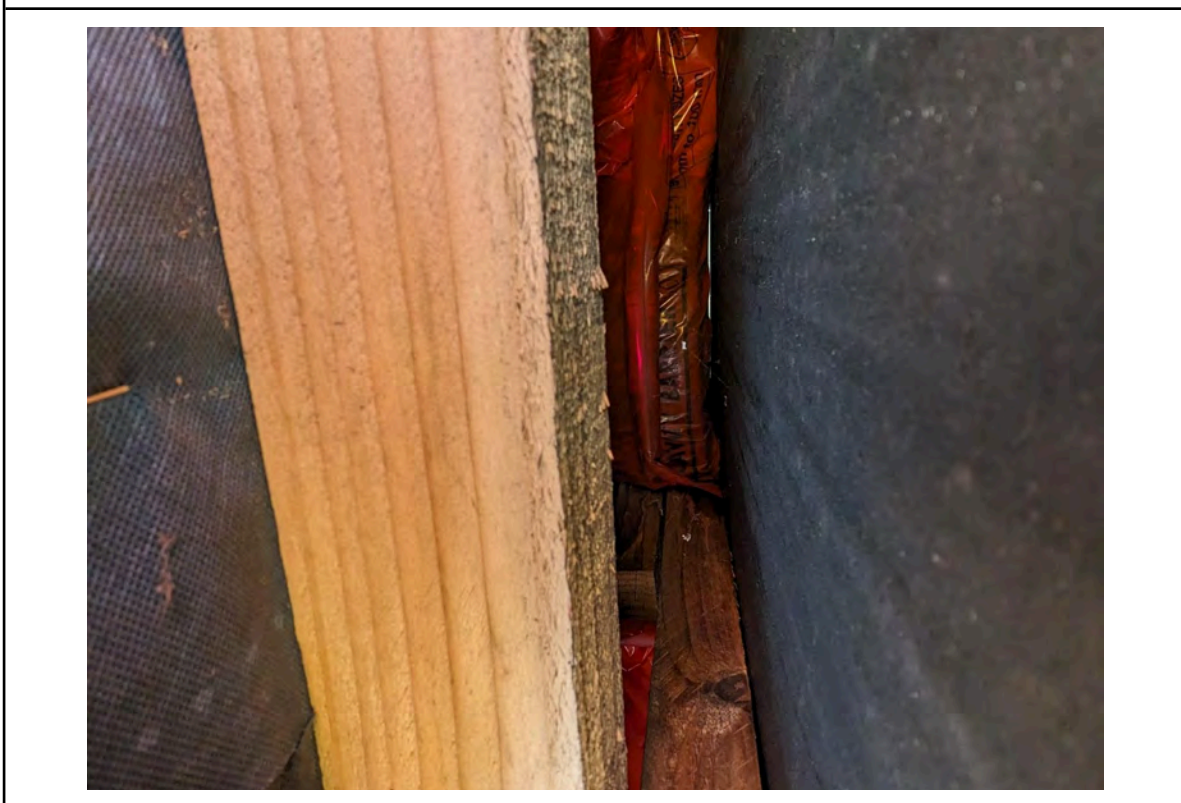
Photo 14: Location 5 - Cavity of cavity barrier, breather membrane and timber studs

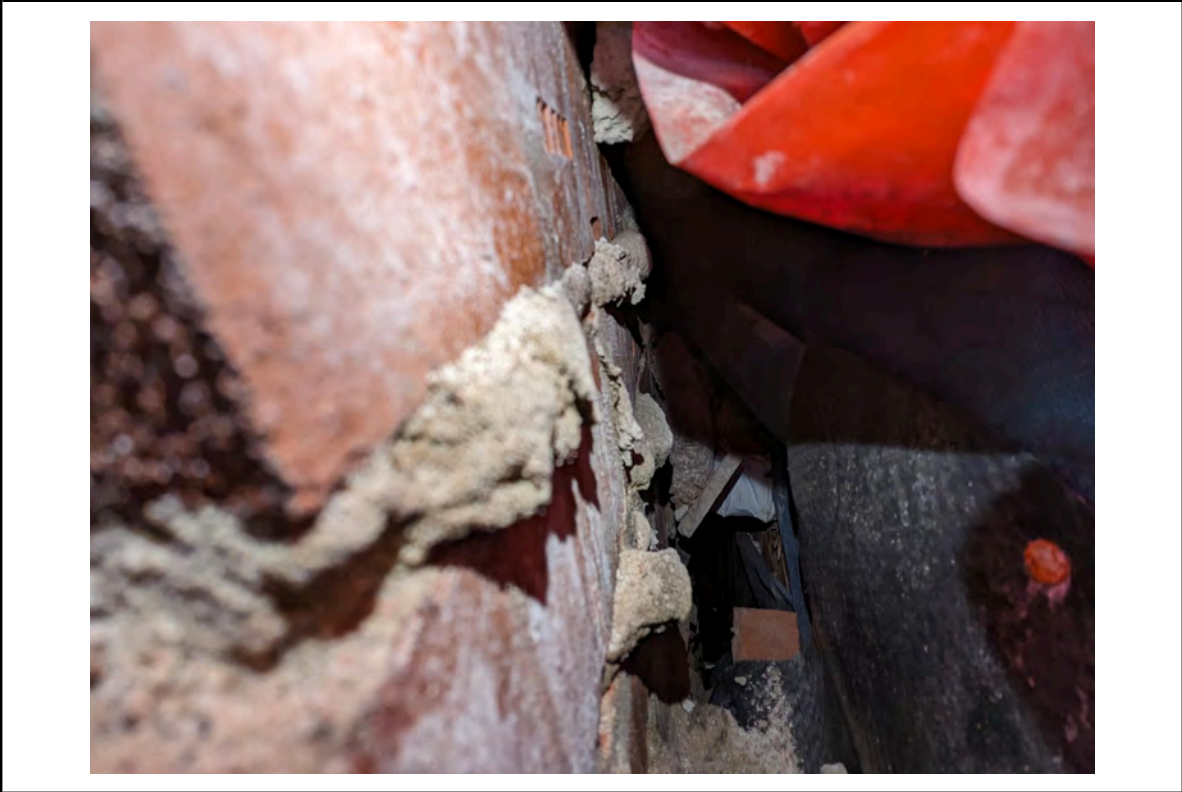
Photo 16: Location 6 - Cavity with damp proof membrane, breather membrane and cavity barriers

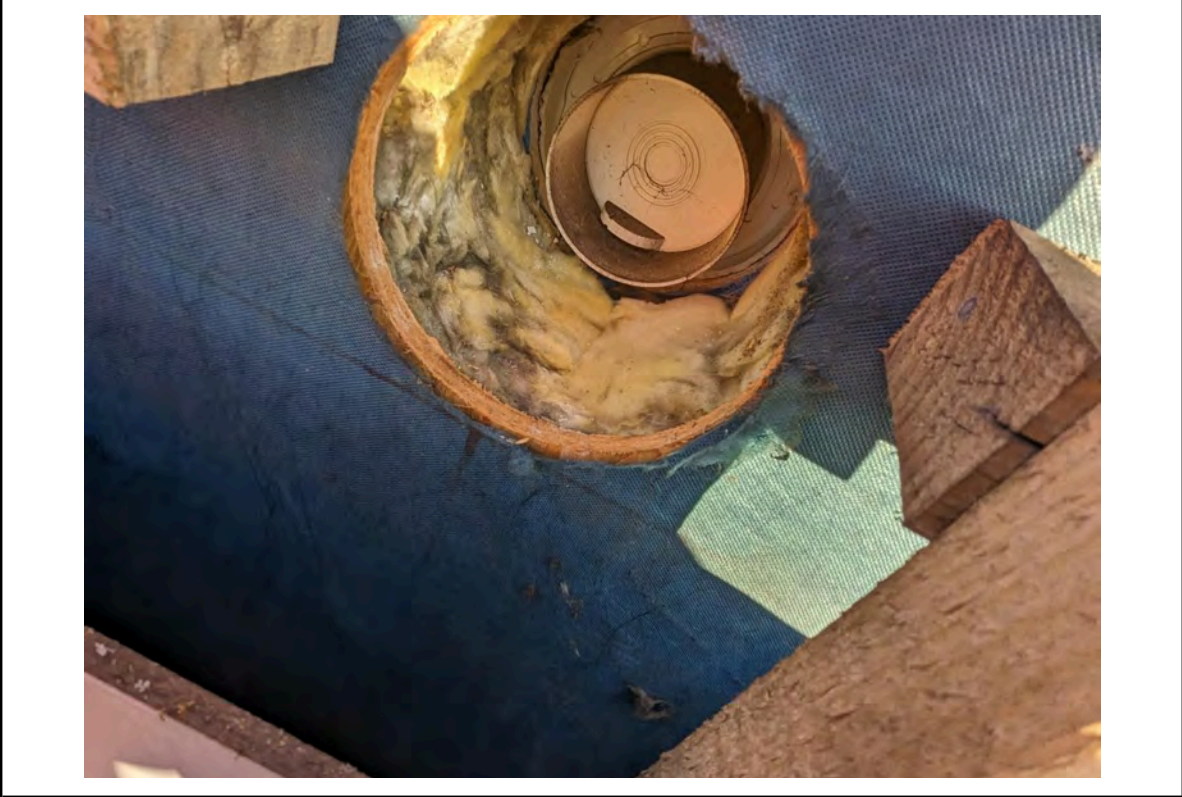
Photo 18: Location 7 - HPL facade build up

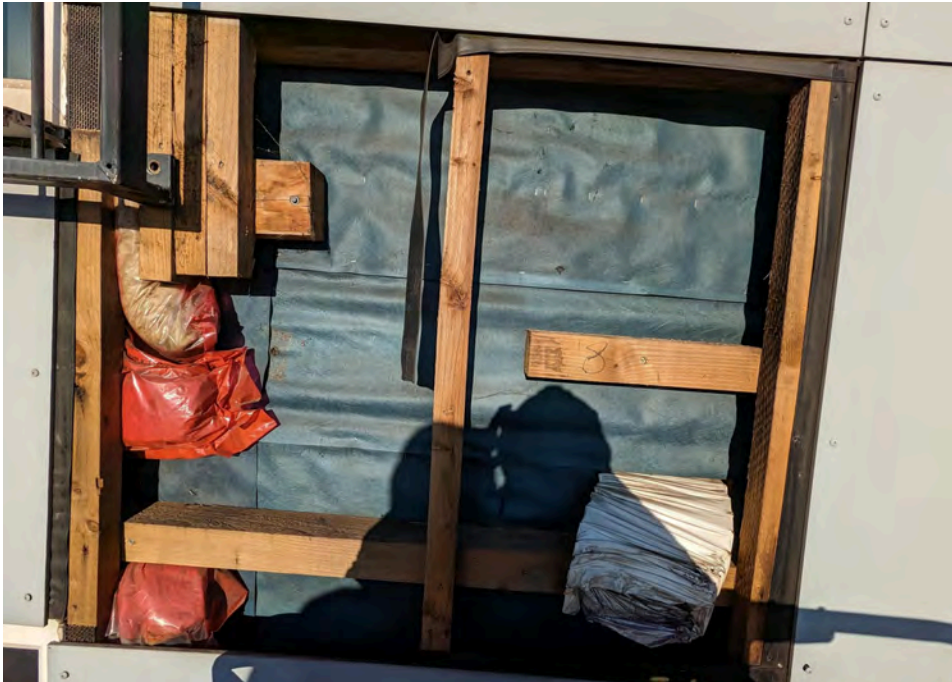
Photo 19: Location 8 - HPL removed on 3rd floor at south elevation

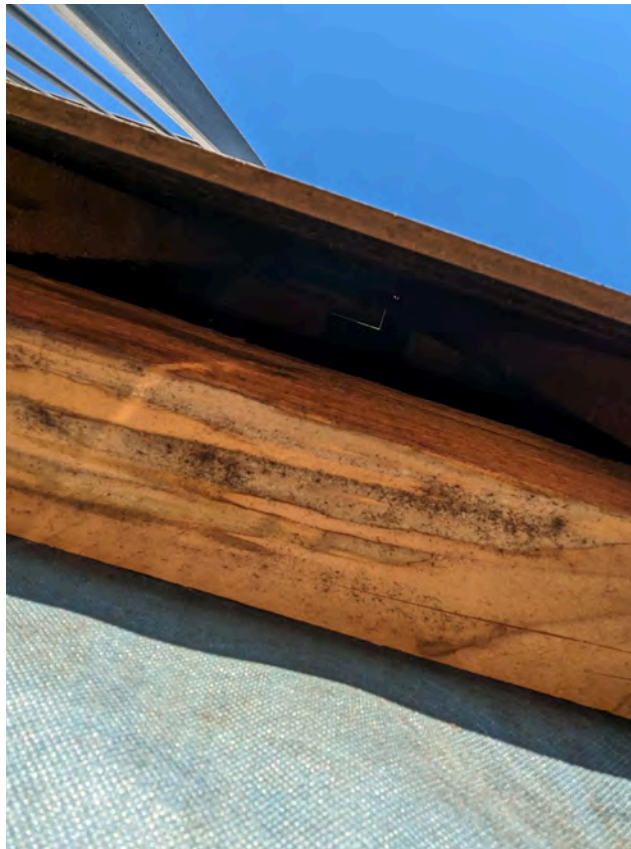
Photo 20: Location 8 - Cavity with timber studs and breather membrane, no horizontal barriers between compartment floors

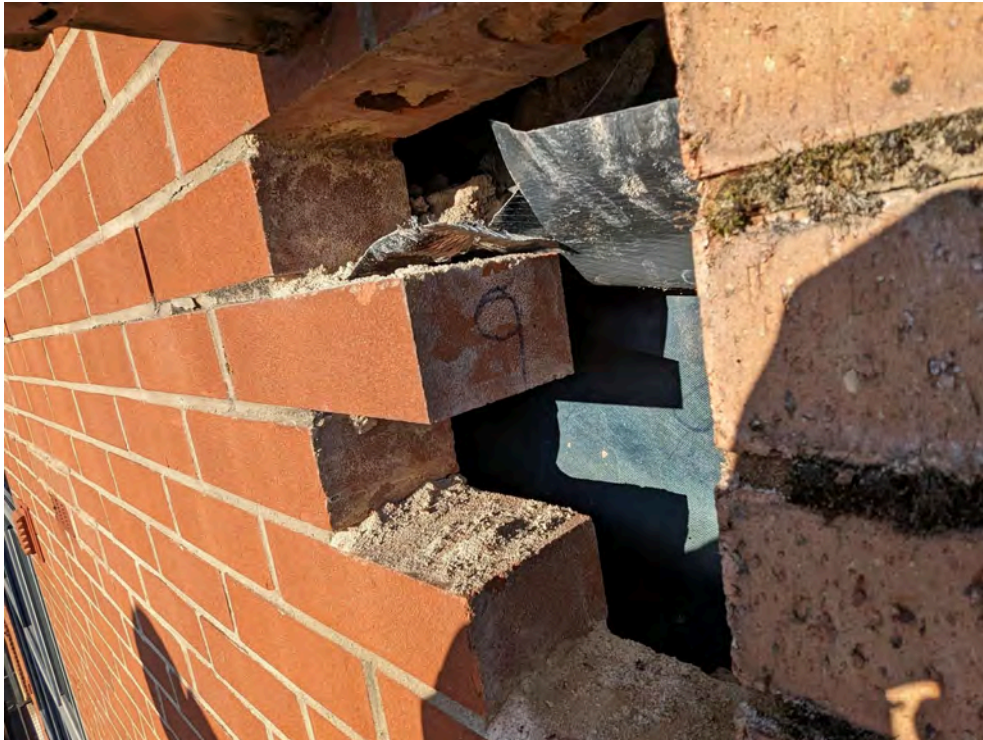
Photo 21: Location 9 - Brick removed on 2nd floor at south elevation

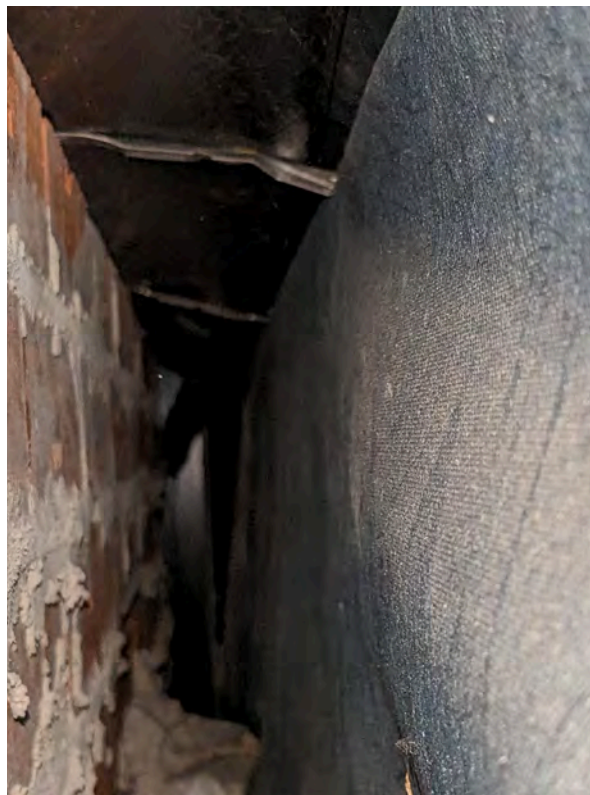
Photo 22: Location 9 - Cavity with wall ties, breather membrane and damp proof membrane and barriers

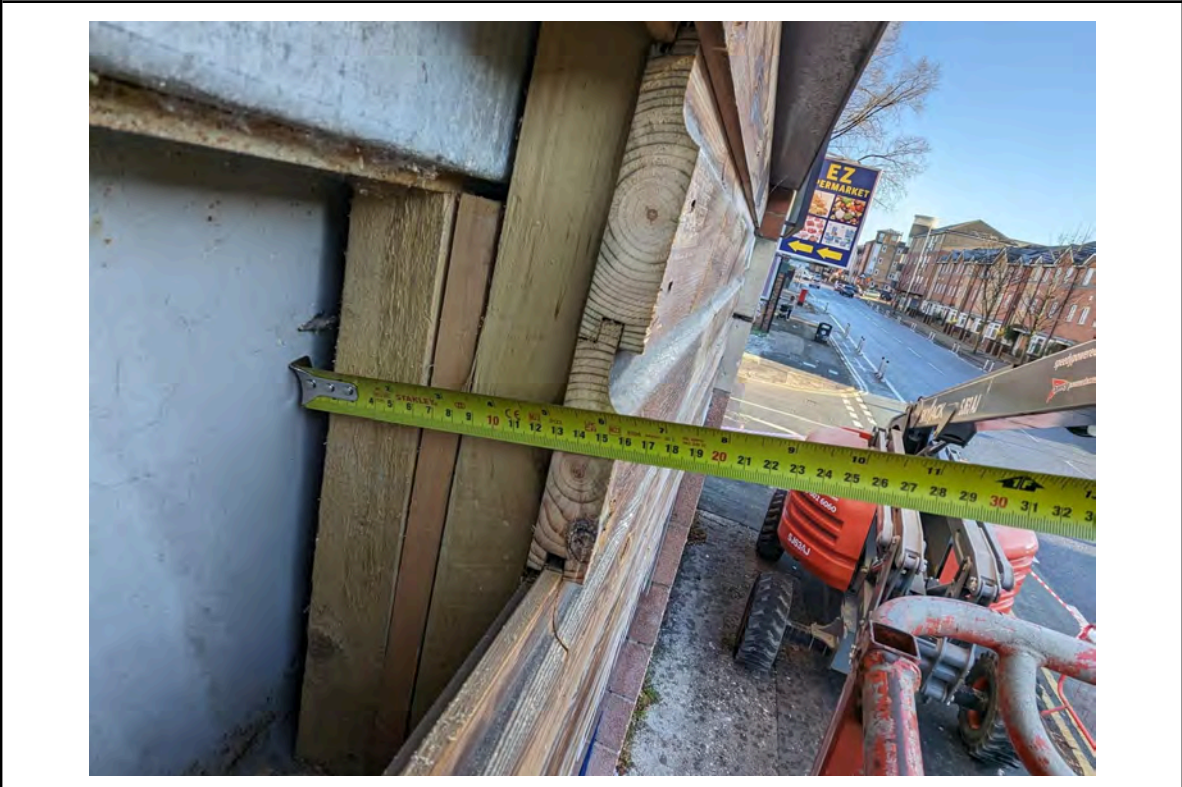
Photo 24: Location 10 - timber spandrel panel build up

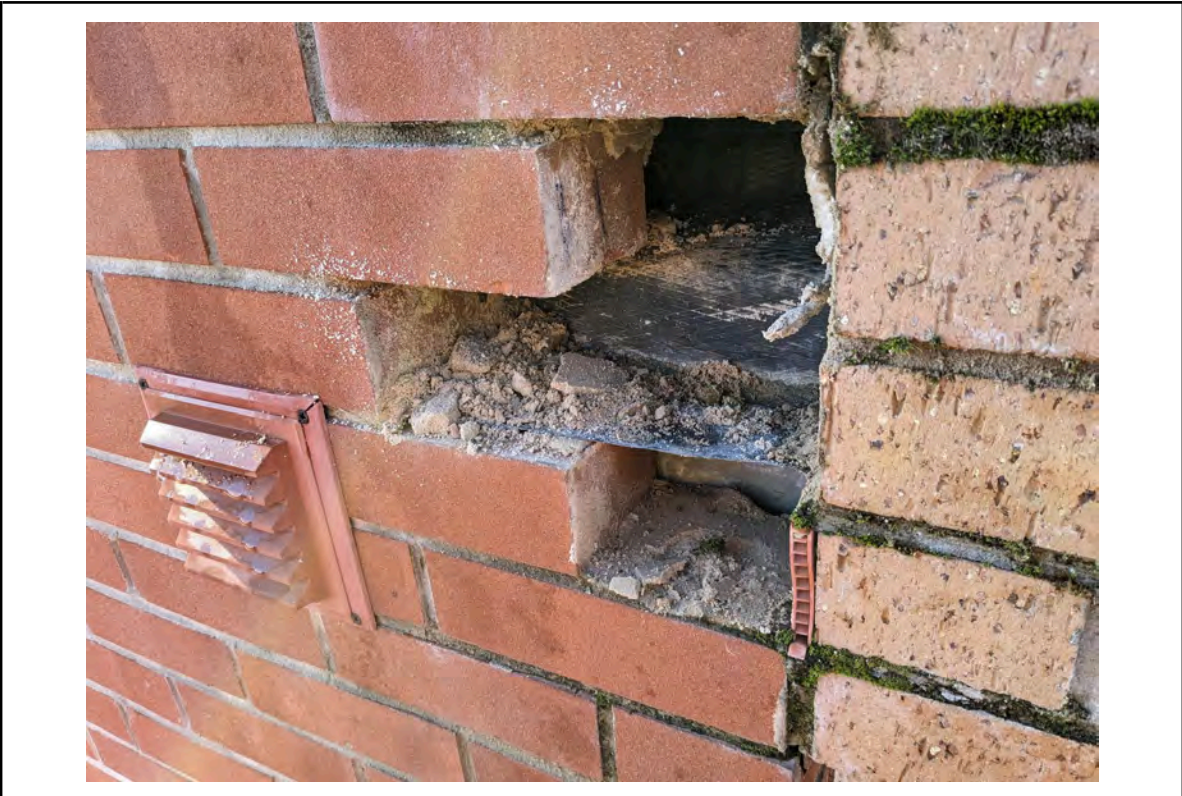
Photo 25: Location 11 - Brick removed on 2nd floor at east elevation

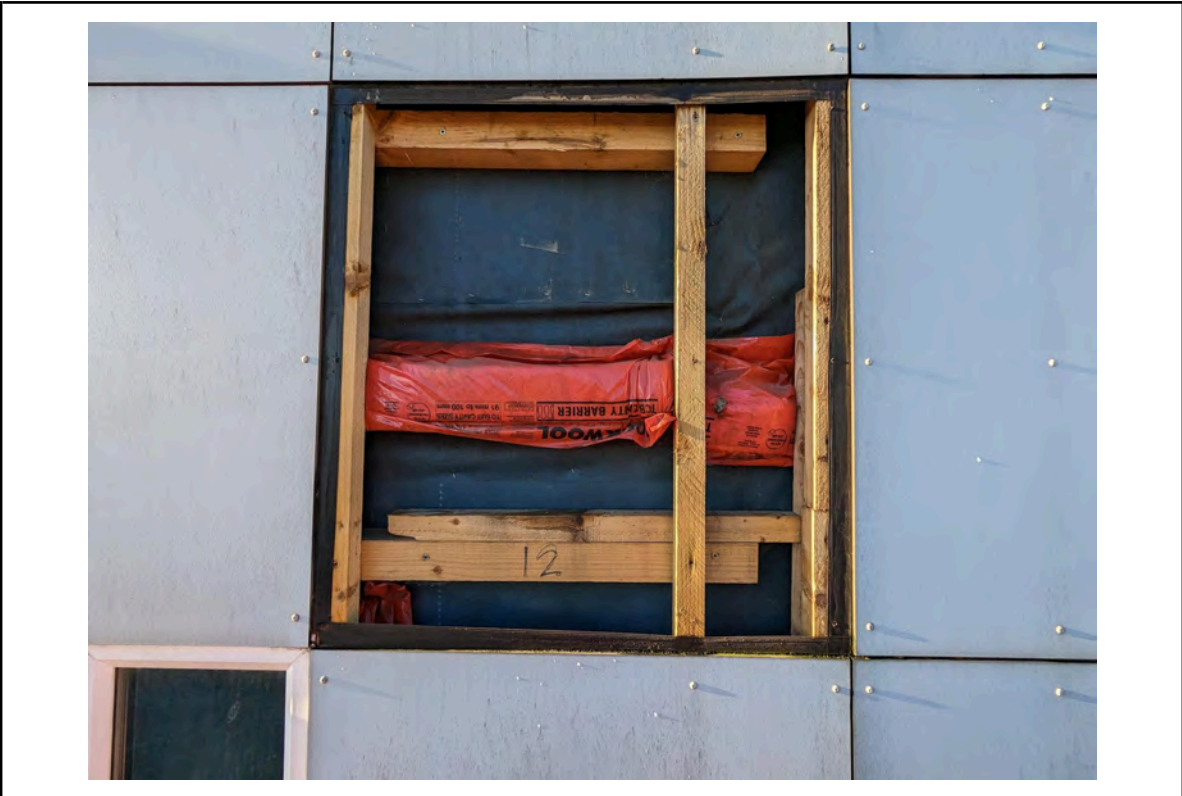
Photo 27: Location 12 - HPL removed on 3rd floor at east elevation

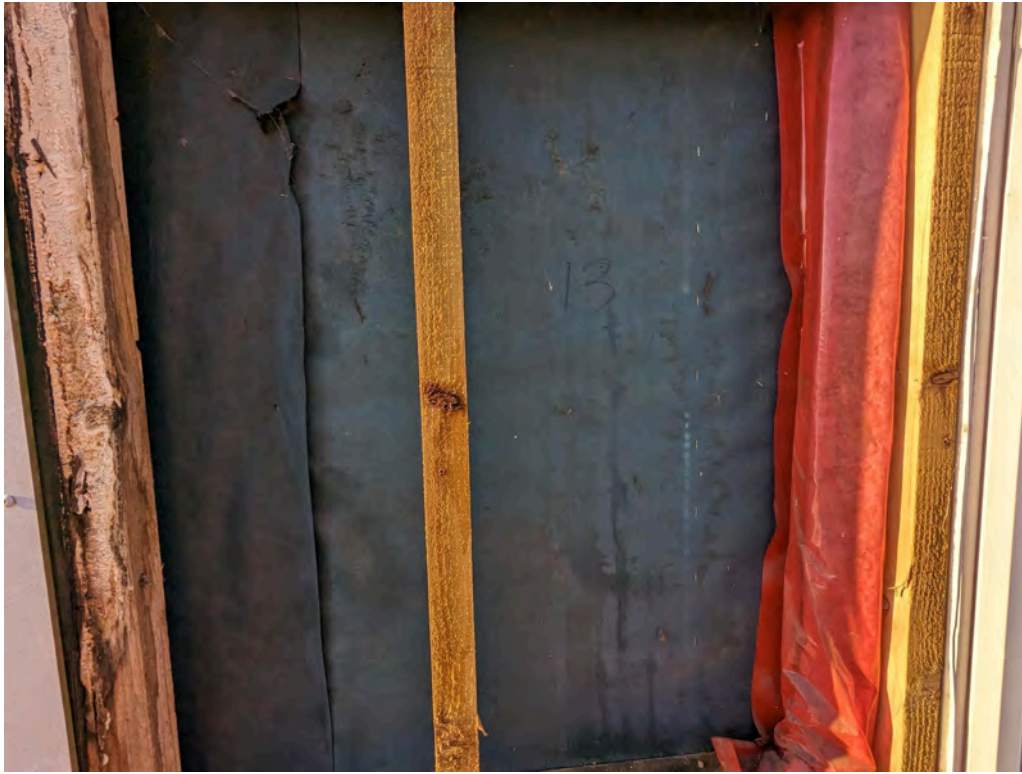
Photo 29: Location 13 - HPL removed on 2nd floor at east elevation

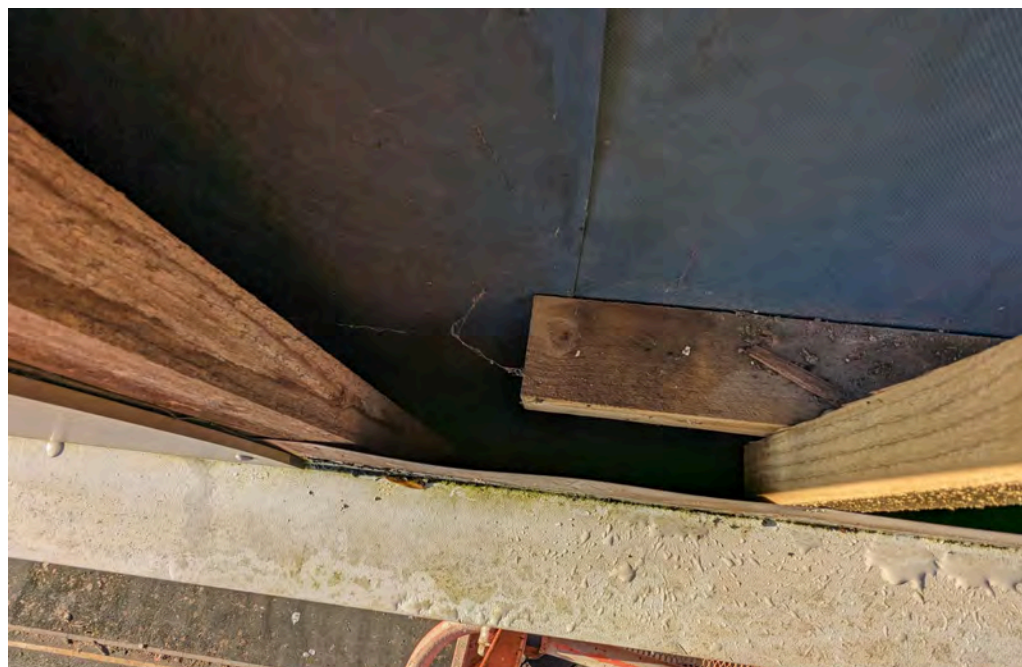
Photo 30: Location 13 - Cavity with timber studs, breather membrane and vertical barriers, but no horizontal barrier between floors.

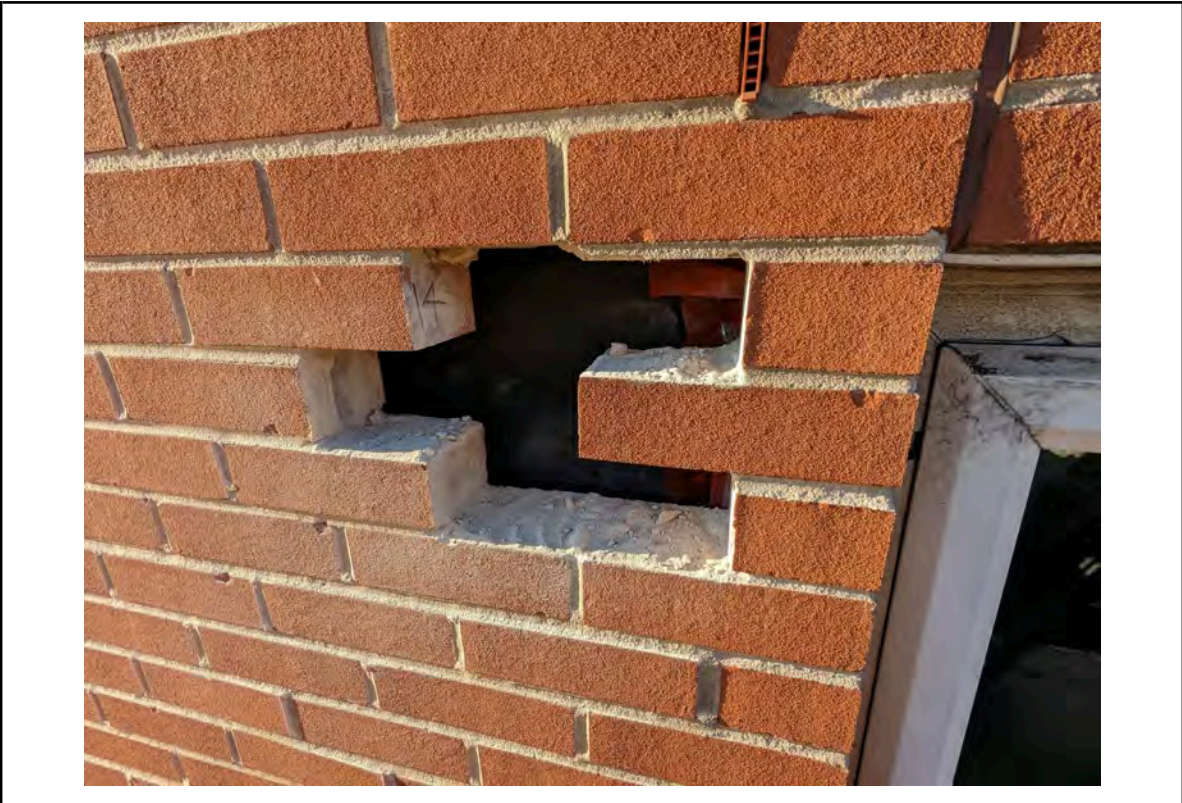
Photo 31: Location 14 - Brick removed on 2nd floor at east elevation

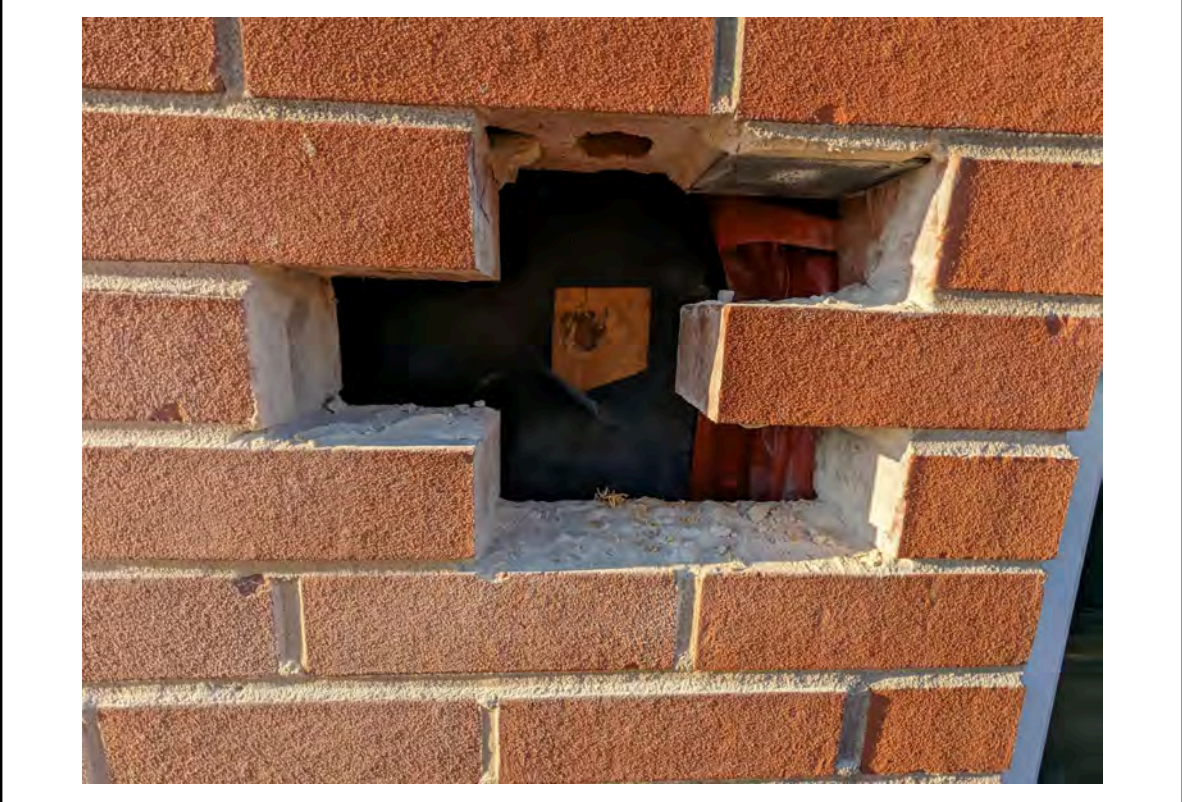
Photo 32: Location 14 - Brick build up

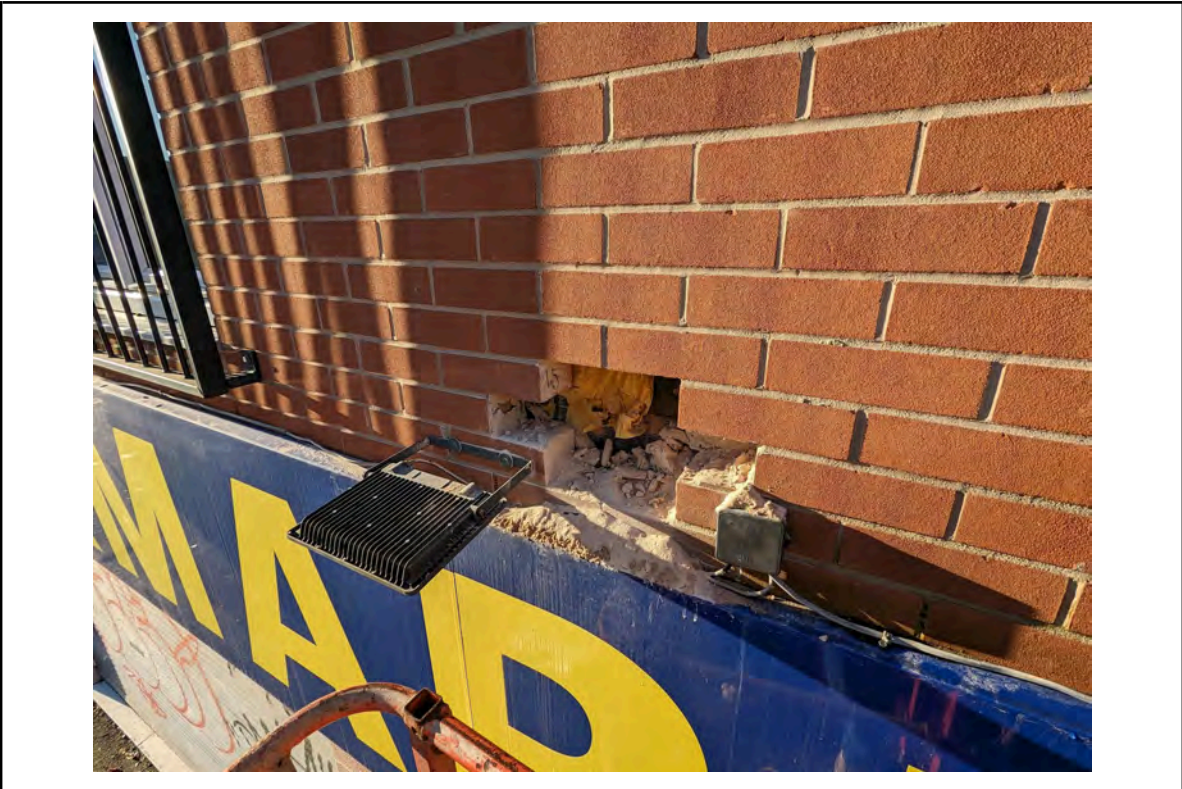
Photo 33: Location 15 - Brick removed on 1st floor at east elevation

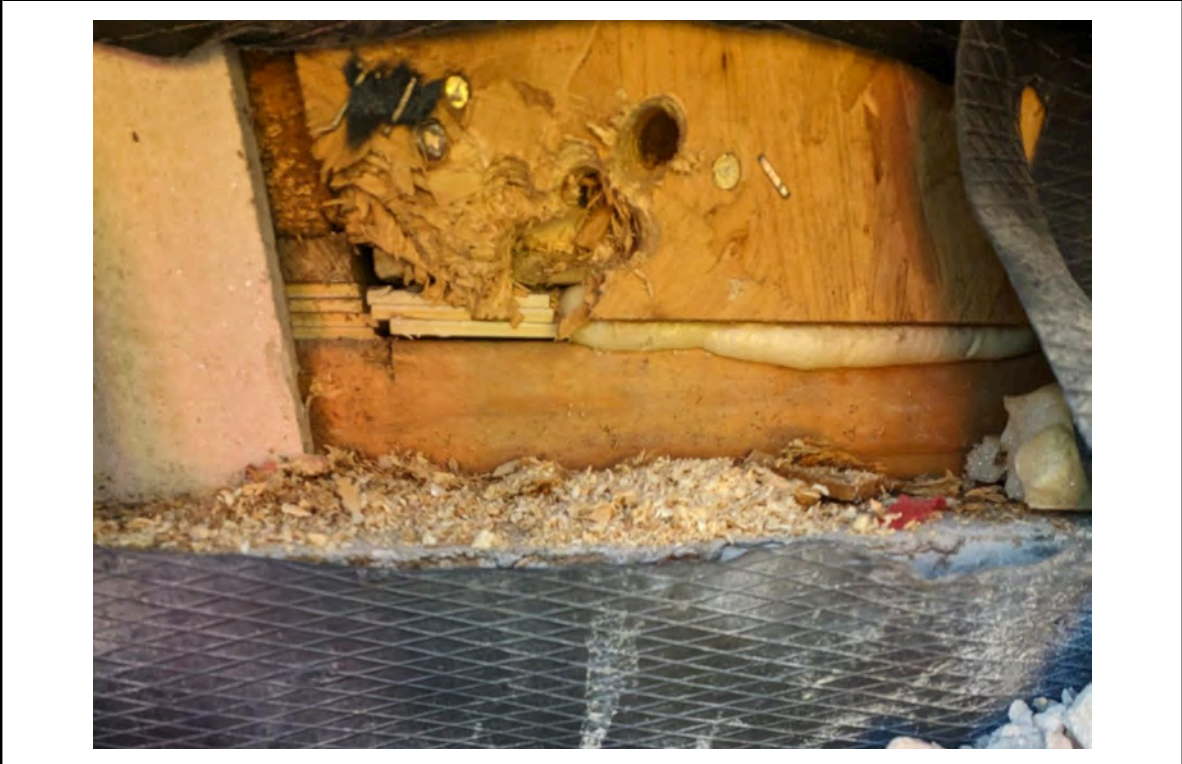
Photo 34: Location 15 - Cavity with damp proof membrane, breather membrane and timber frame

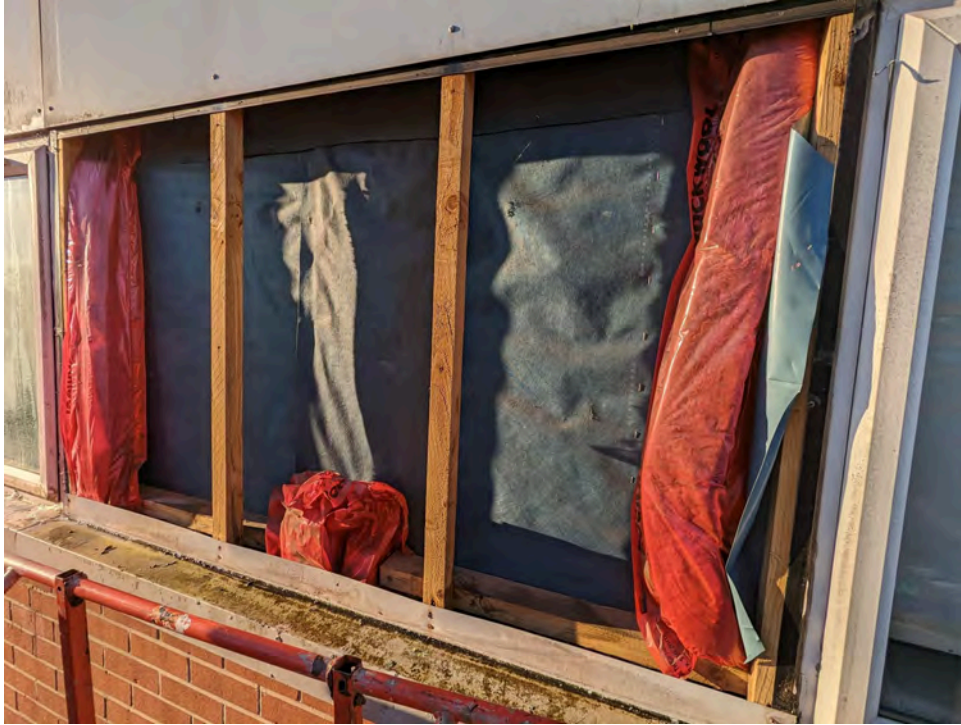
Photo 35: Location 16 - HPL removed on 3rd floor at east elevation

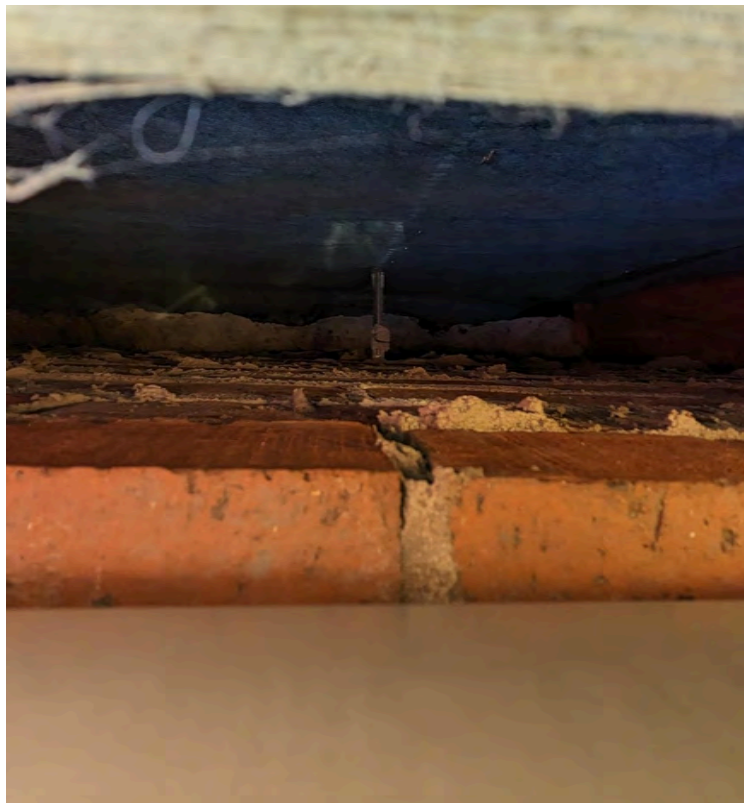
Photo 36: Location 16 - Cavity with breather membrane, wall ties, cavity closer, but no cavity barriers.

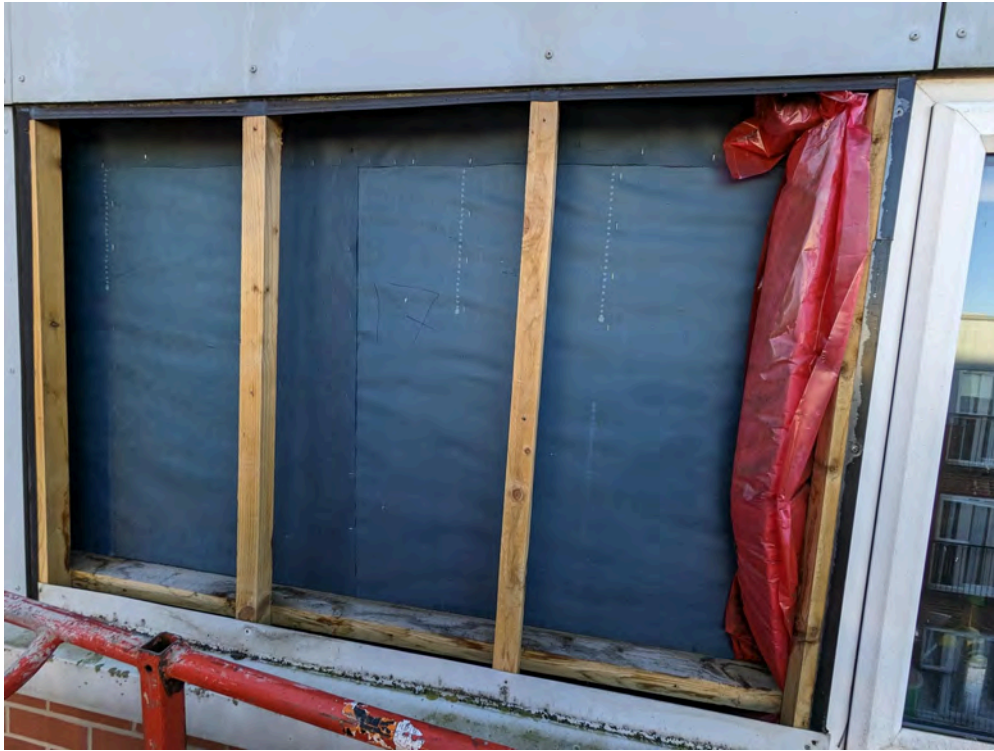
Photo 37: Location 17 - HPL removed on 3rd floor at north elevation

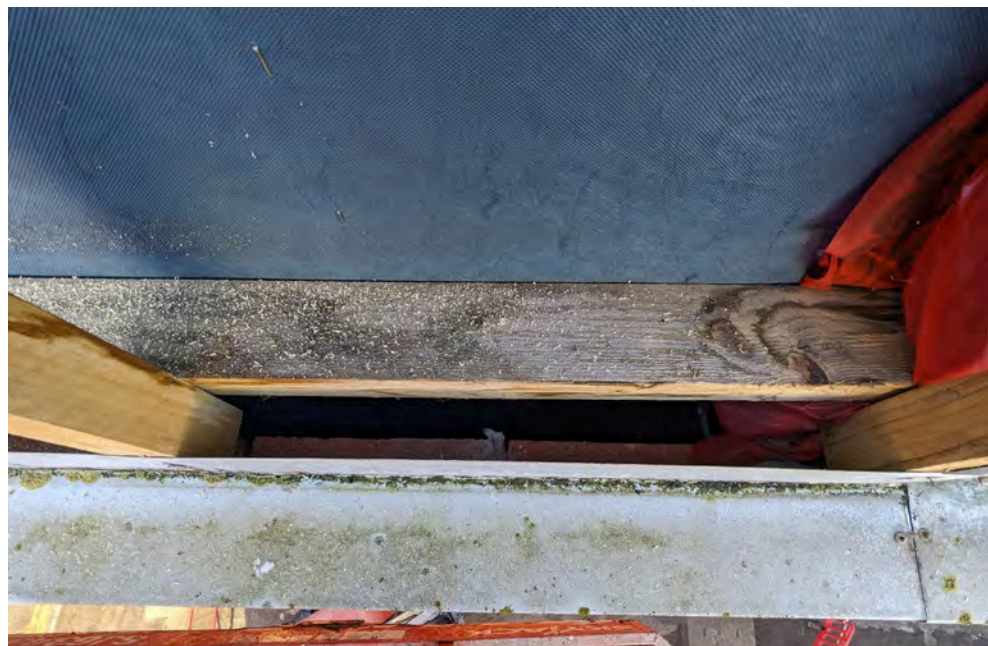
Photo 38: Location 17 - Cavity showing the cavity barrier at window openings, but no horizontal barrier between floors

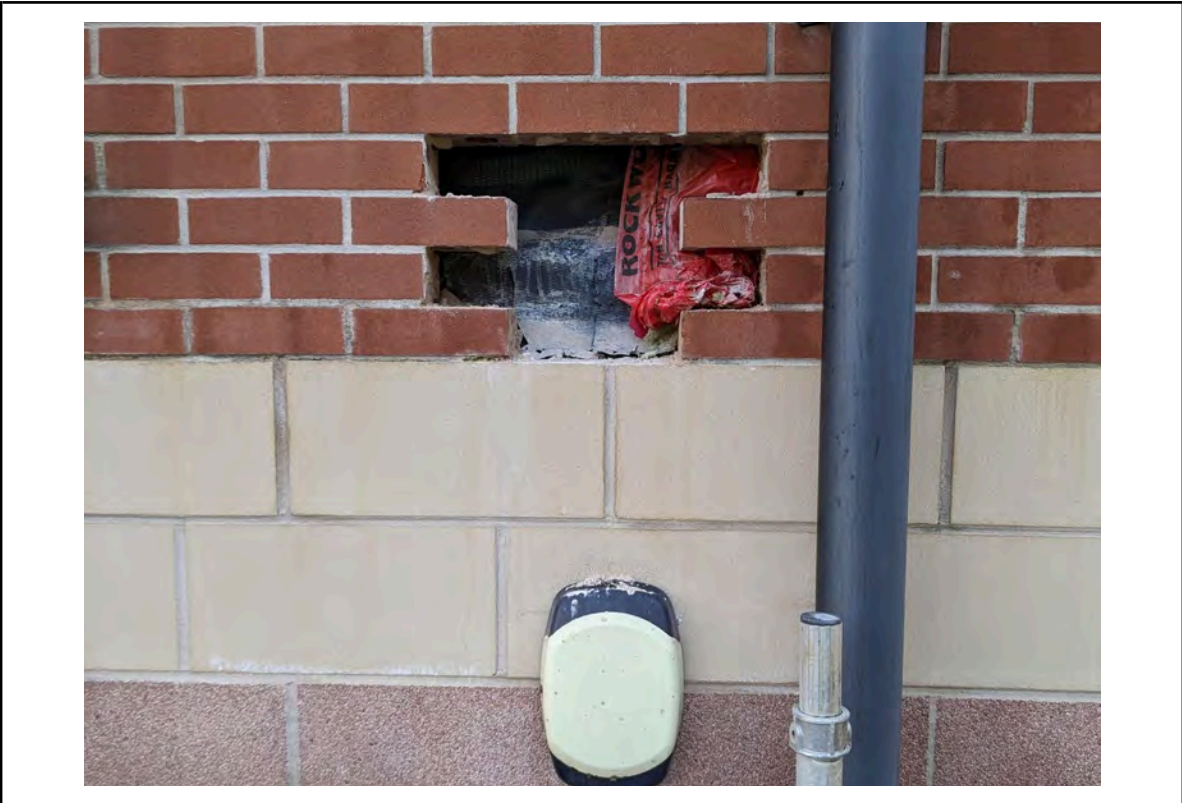
Photo 39: Location 18 - Brick removed on 1st floor at courtyard elevation

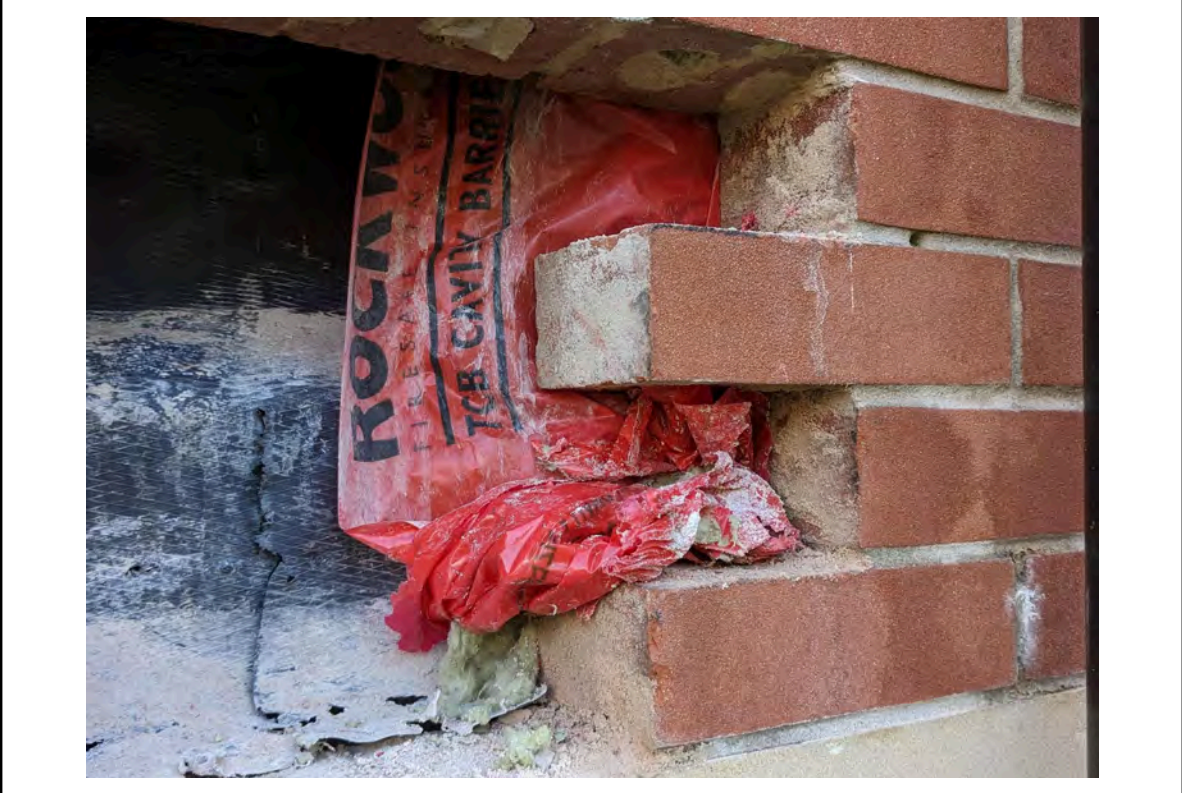
Photo 40: Location 18 - Cavity showing the cavity barrier, cavity tray, breather membrane and wall ties

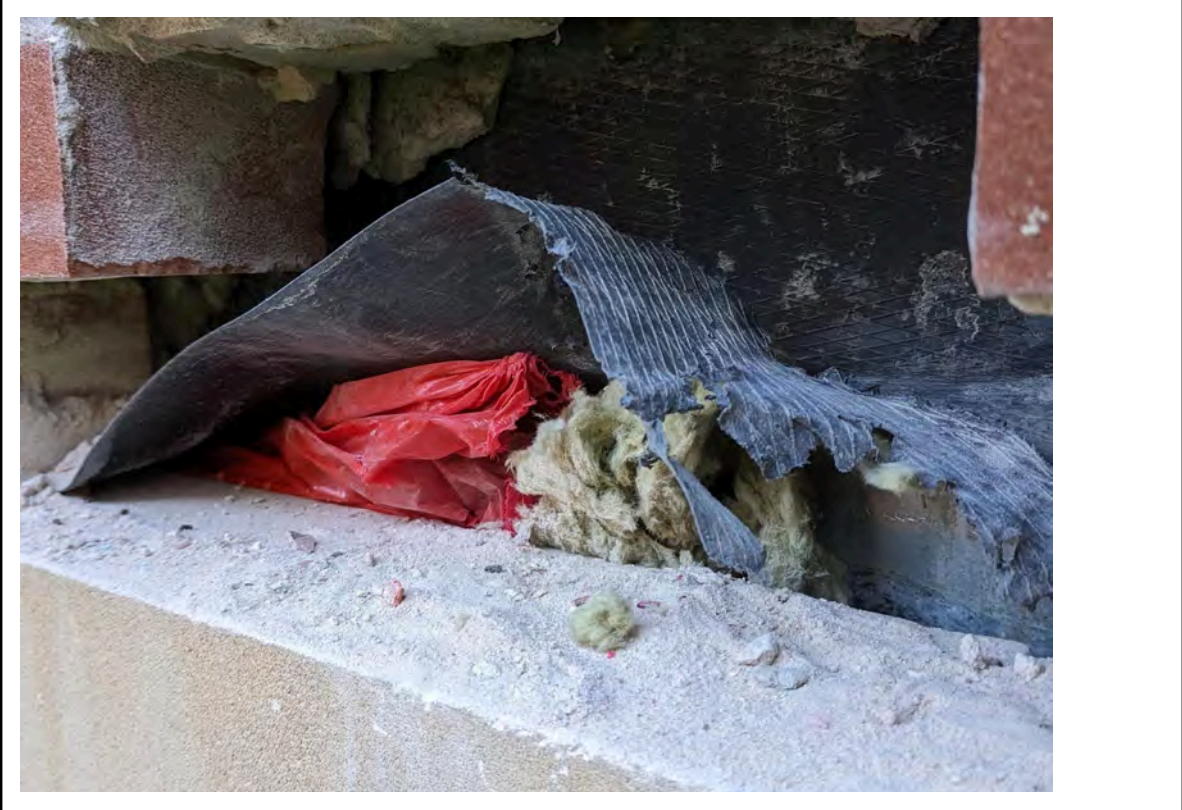
Photo 42: Location 19 - Cavity showing the cavity barrier, cavity tray, breather membrane and wall ties
