35254 - Aura Court, 1 Percy Street, Manchester, Greater  
Manchester, M15 4AB

**Fire Risk Appraisal of the External Wall (FRAEW)**

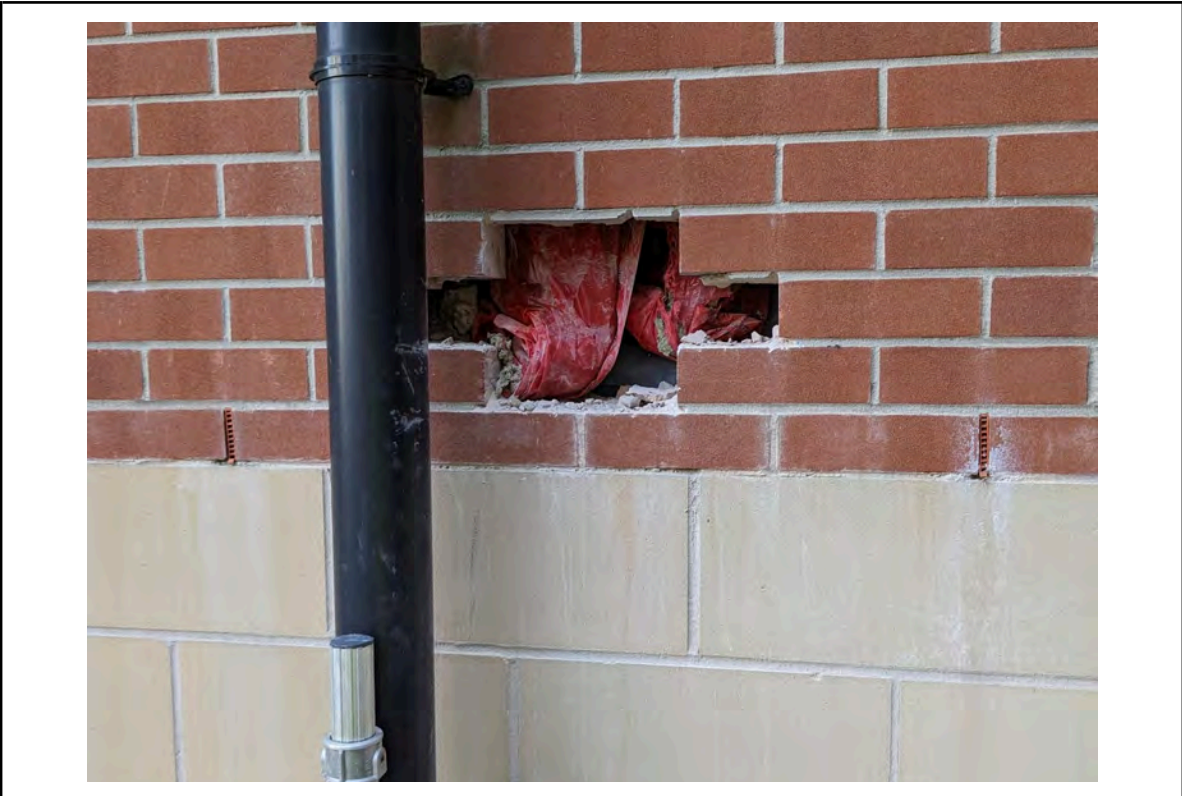
Photo 43: Location 20 - Brick removed on 1st floor at courtyard elevation

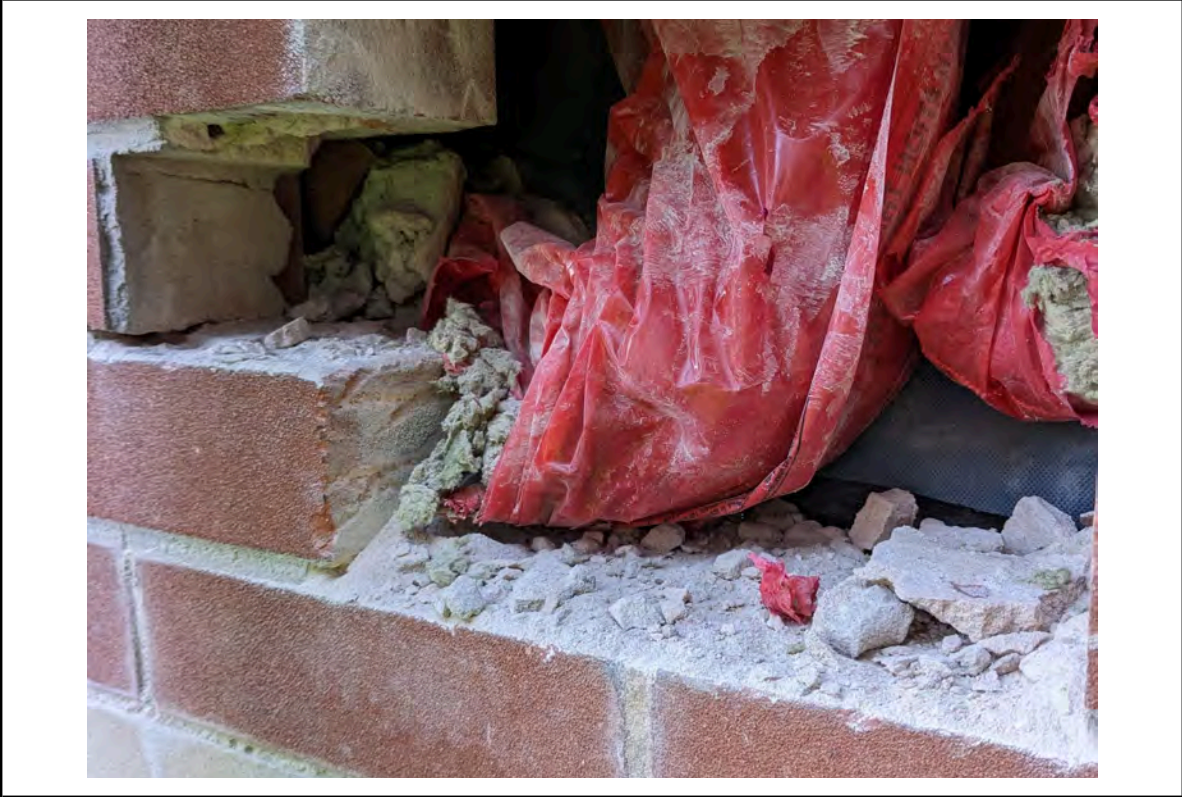
Photo 44: Location 20 - Cavity showing the cavity barrier, cavity tray, breather membrane and wall ties

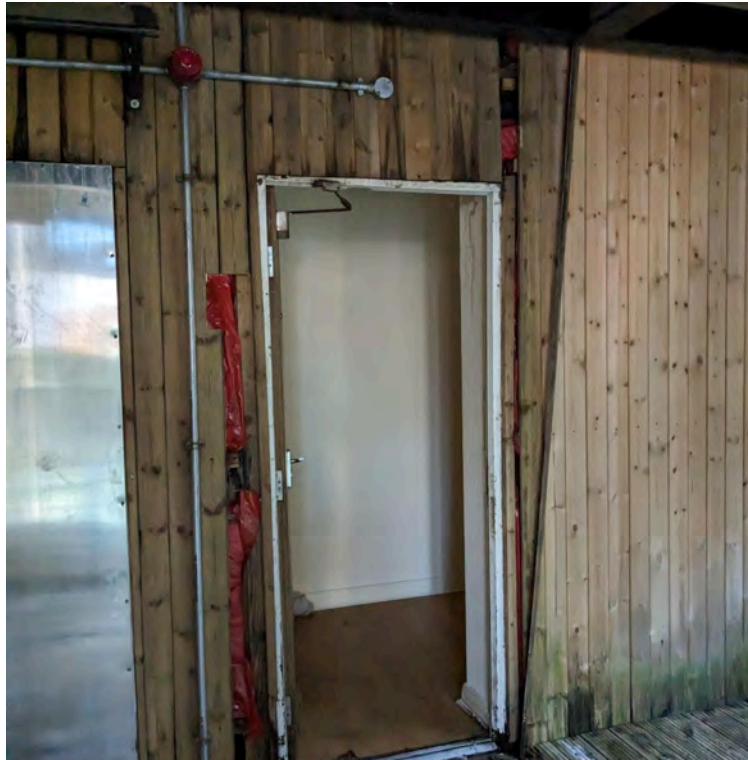
Photo 45: Location 21 - Timber cladding removed on 2nd floor at inner courtyard elevation

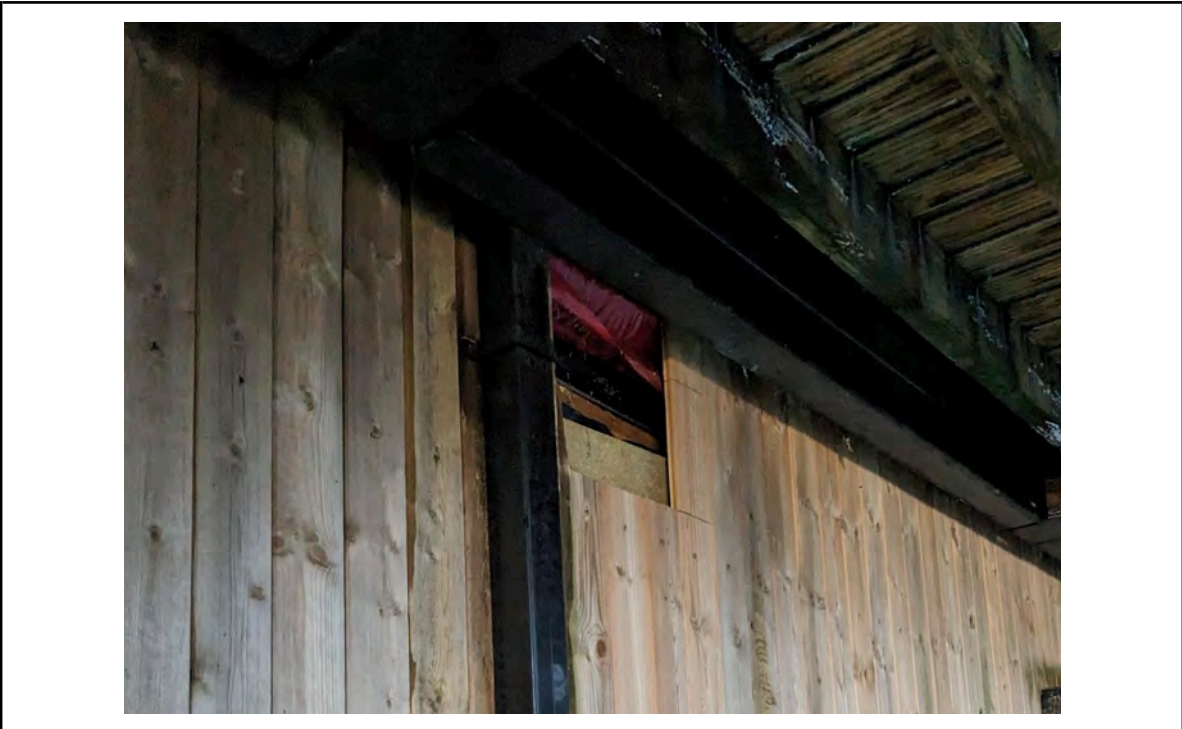
Photo 47: Location 22 - Timber cladding removed on 3rd floor at inner courtyard elevation

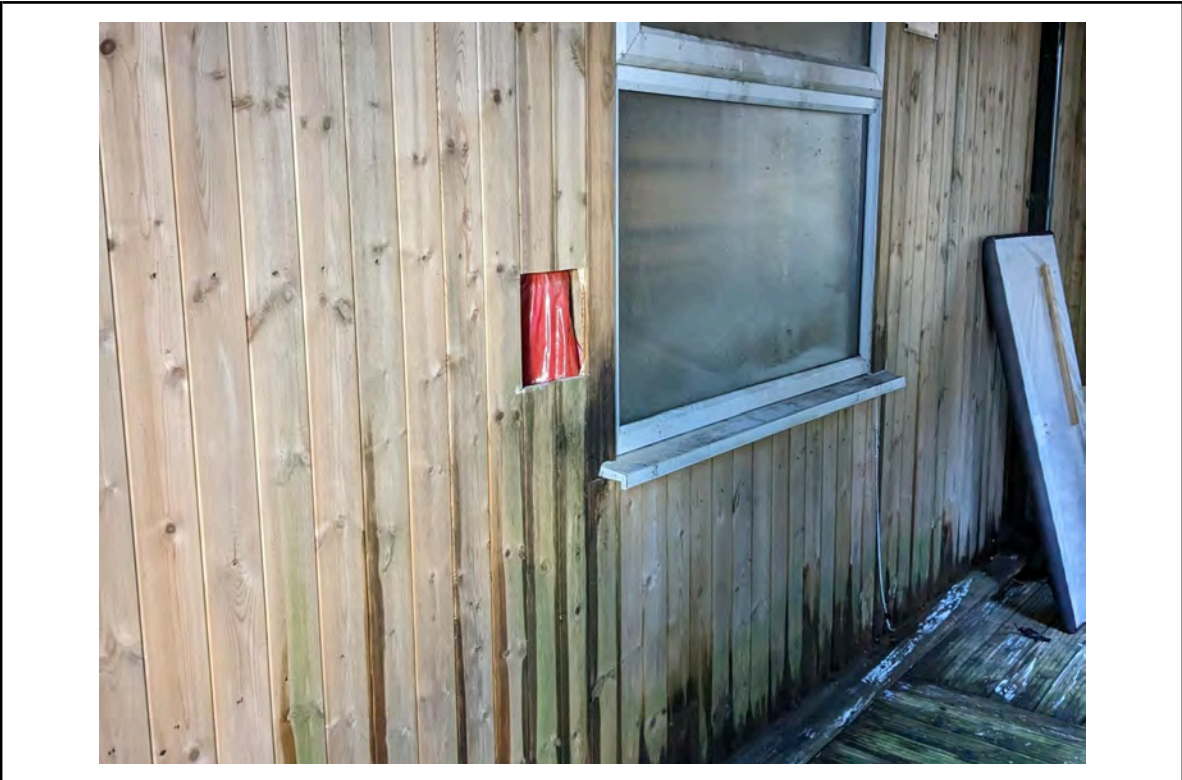
Photo 49: Location 23 - Timber cladding removed on 1st floor at inner courtyard elevation

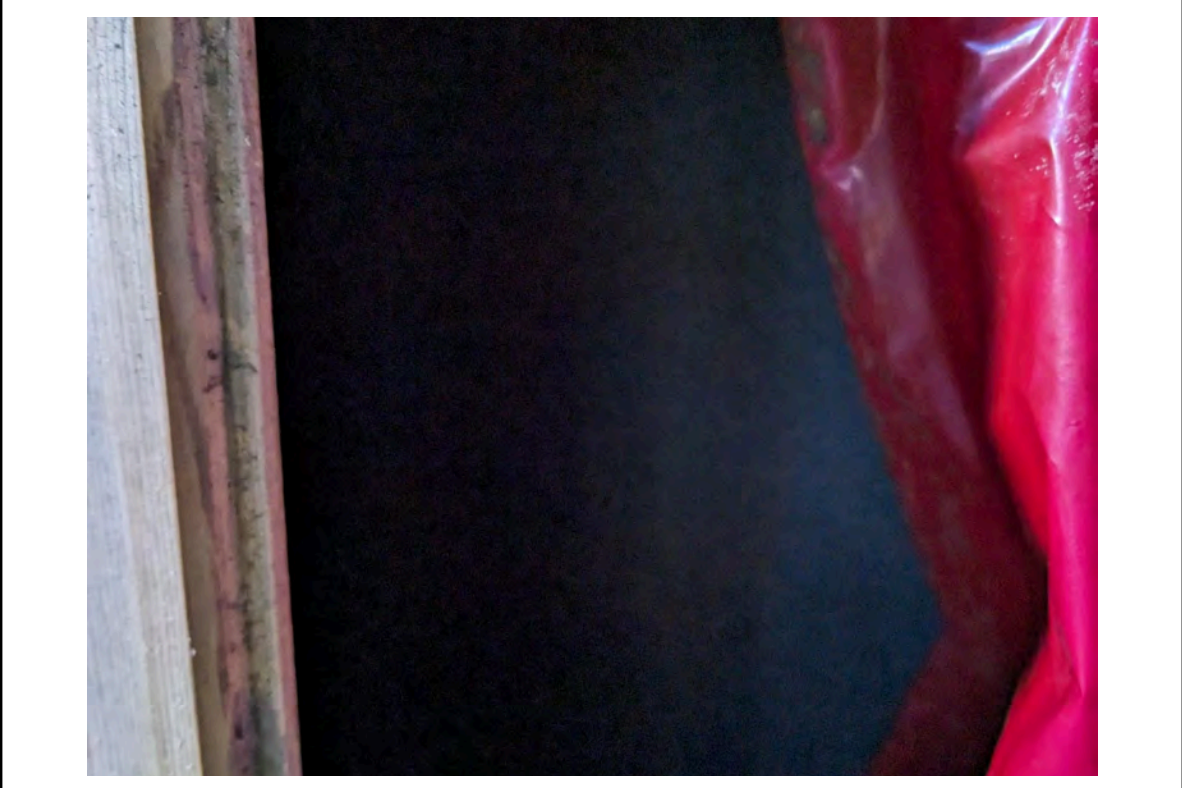
Photo 50: Location 23 - Cavity showing cavity closer at window openings and breather membrane

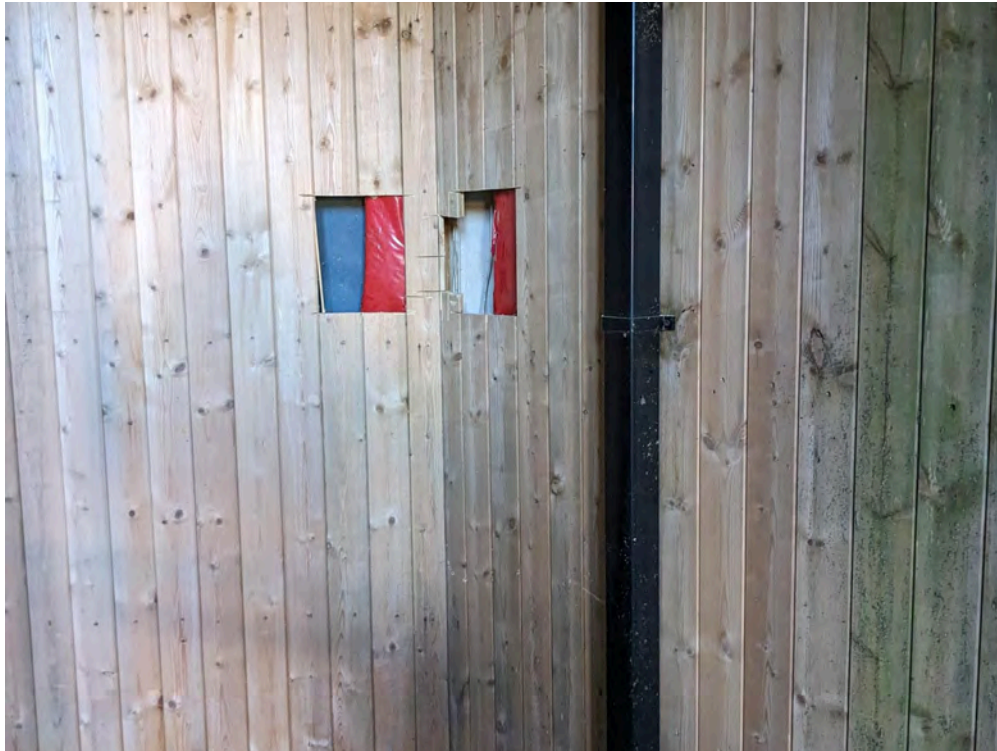
Photo 51: Location 24 - ETICS cored out on 1st floor at side elevation

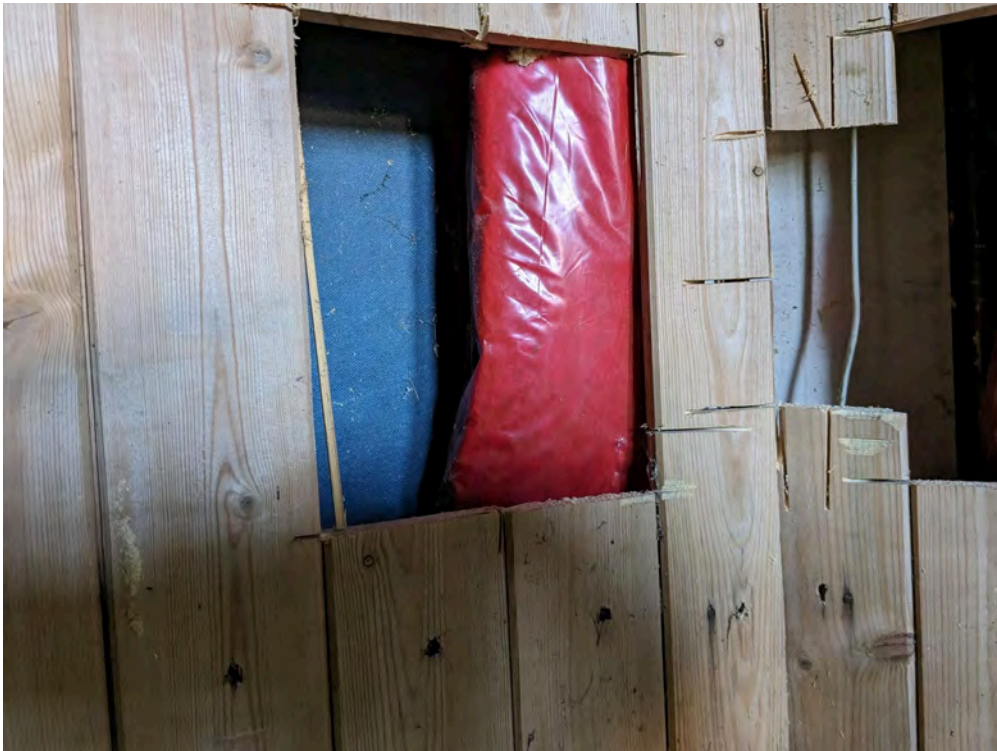
Photo 52: Location 24 - Cavity with vertical barriers, breather membrane and electric wiring with thermoplastic insulation

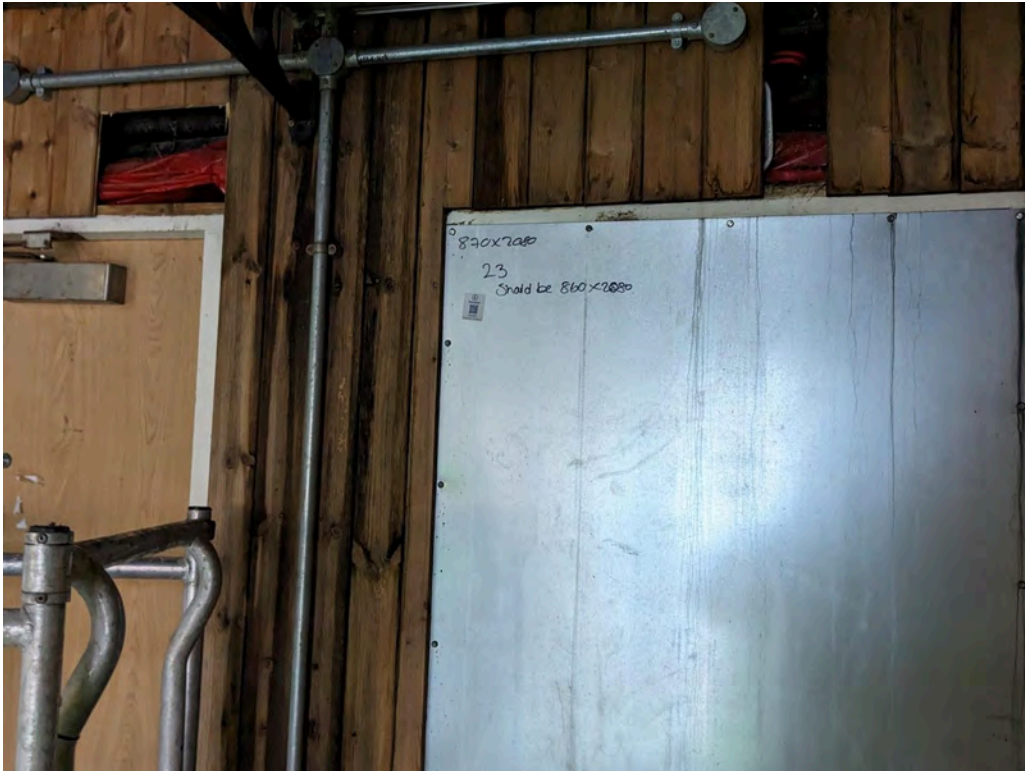
Photo 55: Location 26 - Timber cladding removed on 2nd floor at inner courtyard elevation

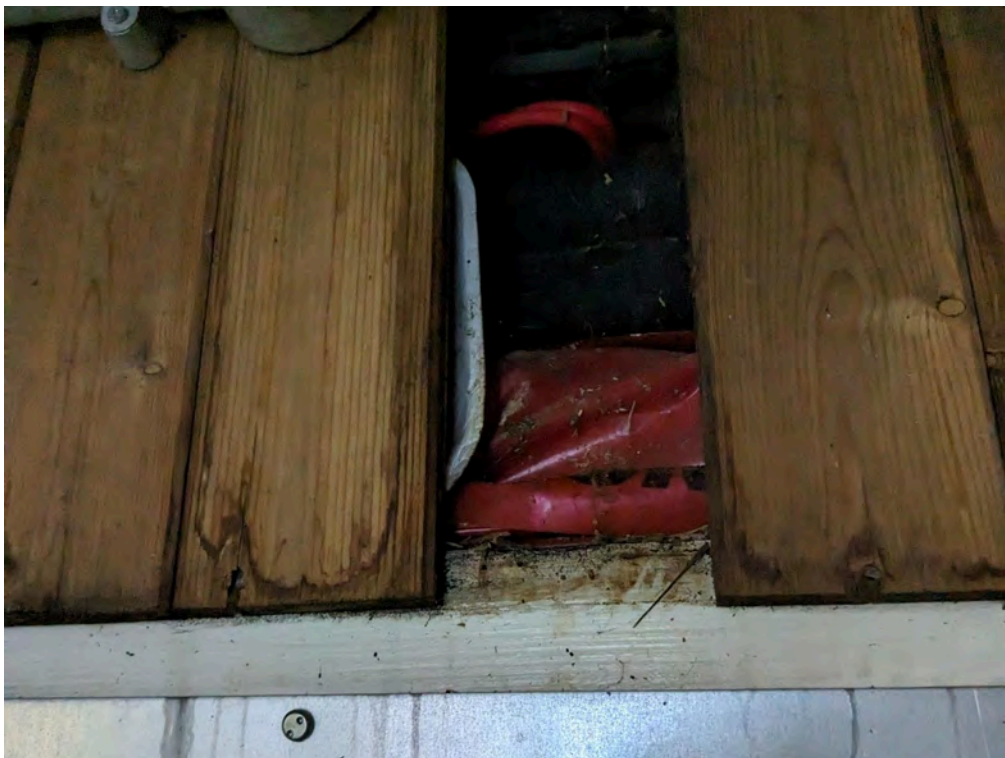
Photo 56: Location 26 - Cavity with cavity closers at door openings, thermoplastic insulations and breather membrane

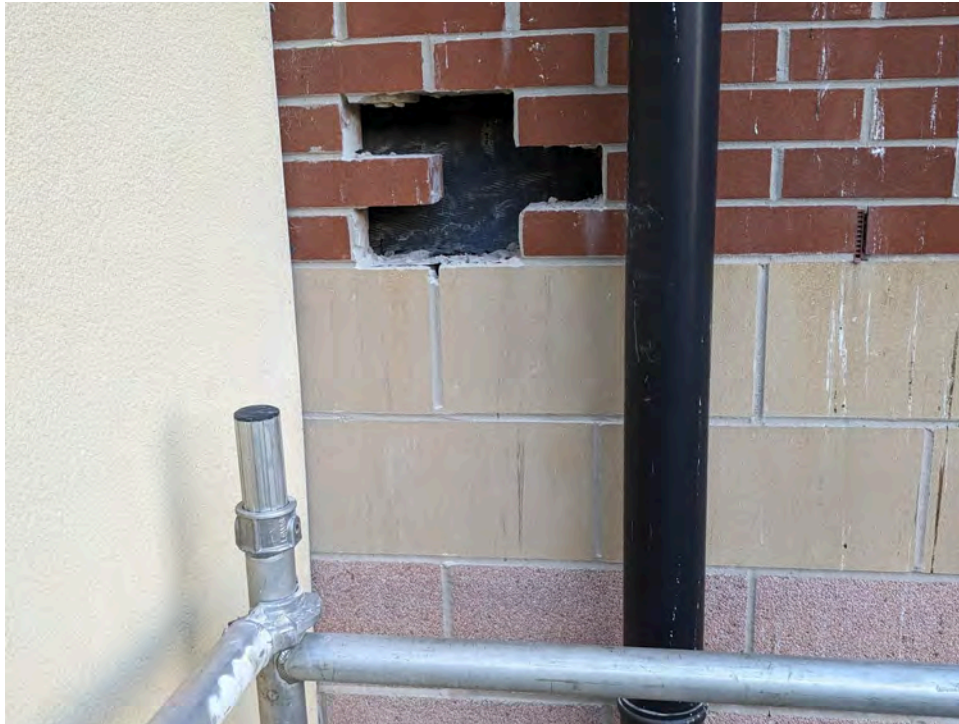
Photo 59: Location 28 - Brick removed at 1st floor at courtyard elevation

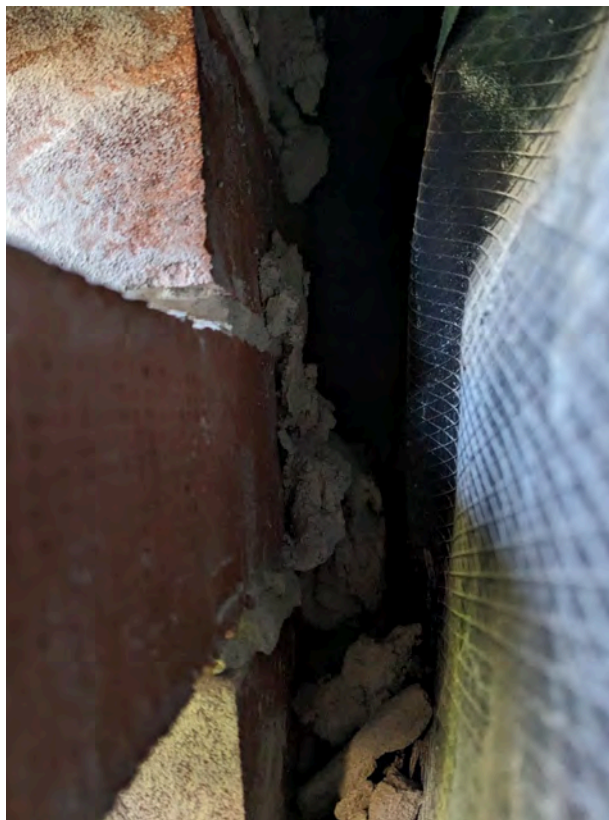
Photo 60: Location 28 - Cavity with no cavity barriers in line with compartment walls and floors

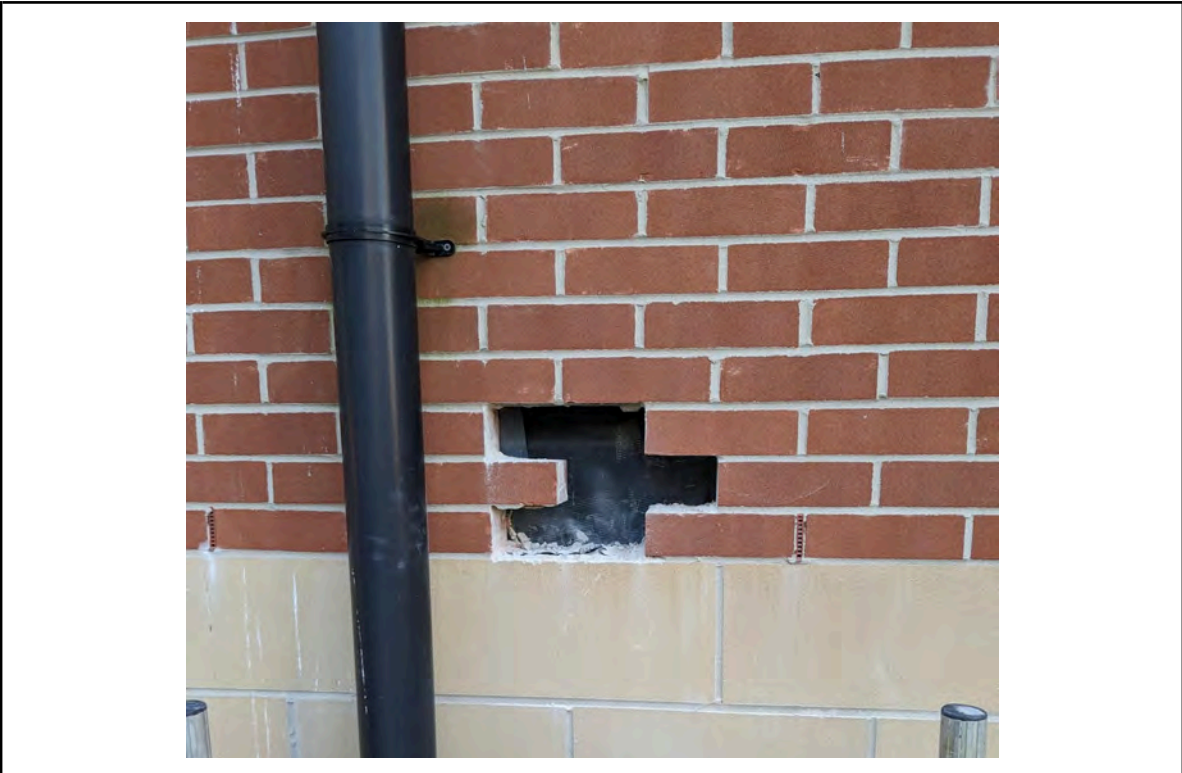
Photo 61: Location 29 - Brick removed at 1st floor at courtyard elevation

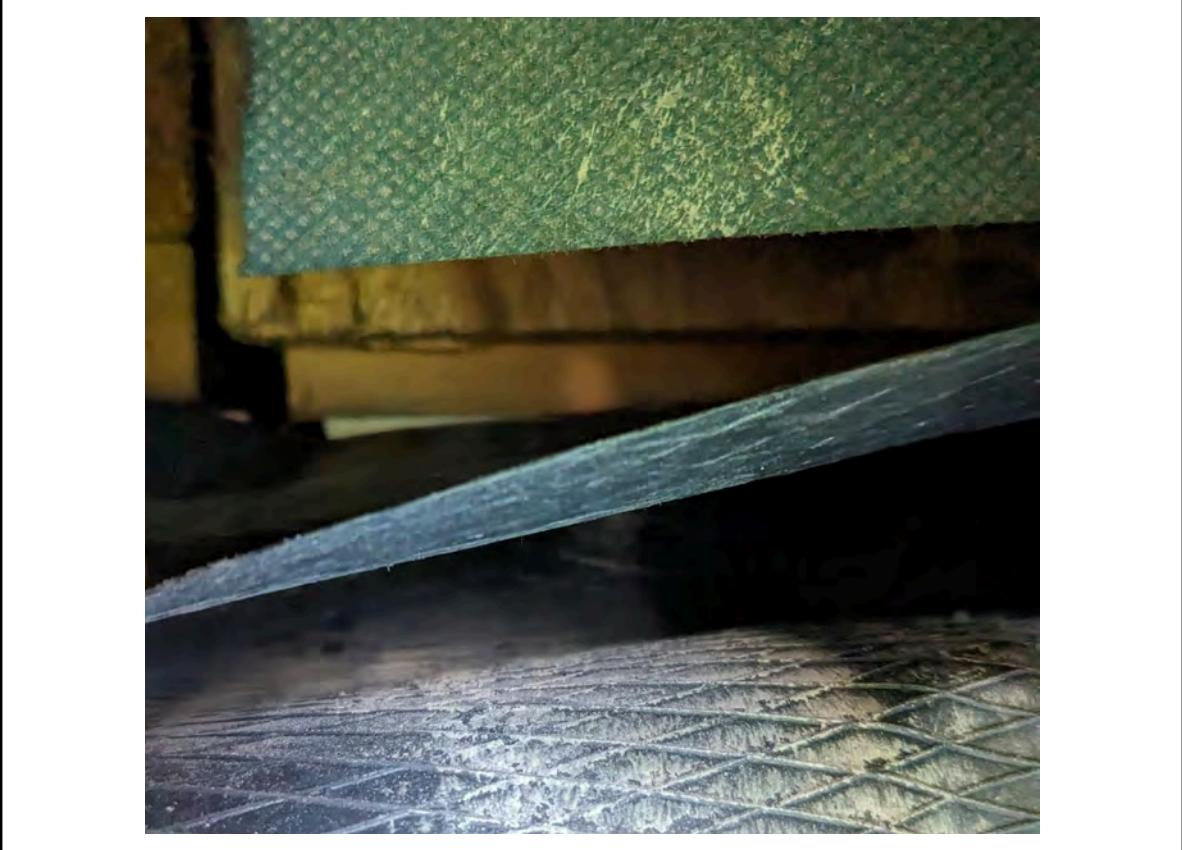
Photo 62: Location 29 - Brick build up

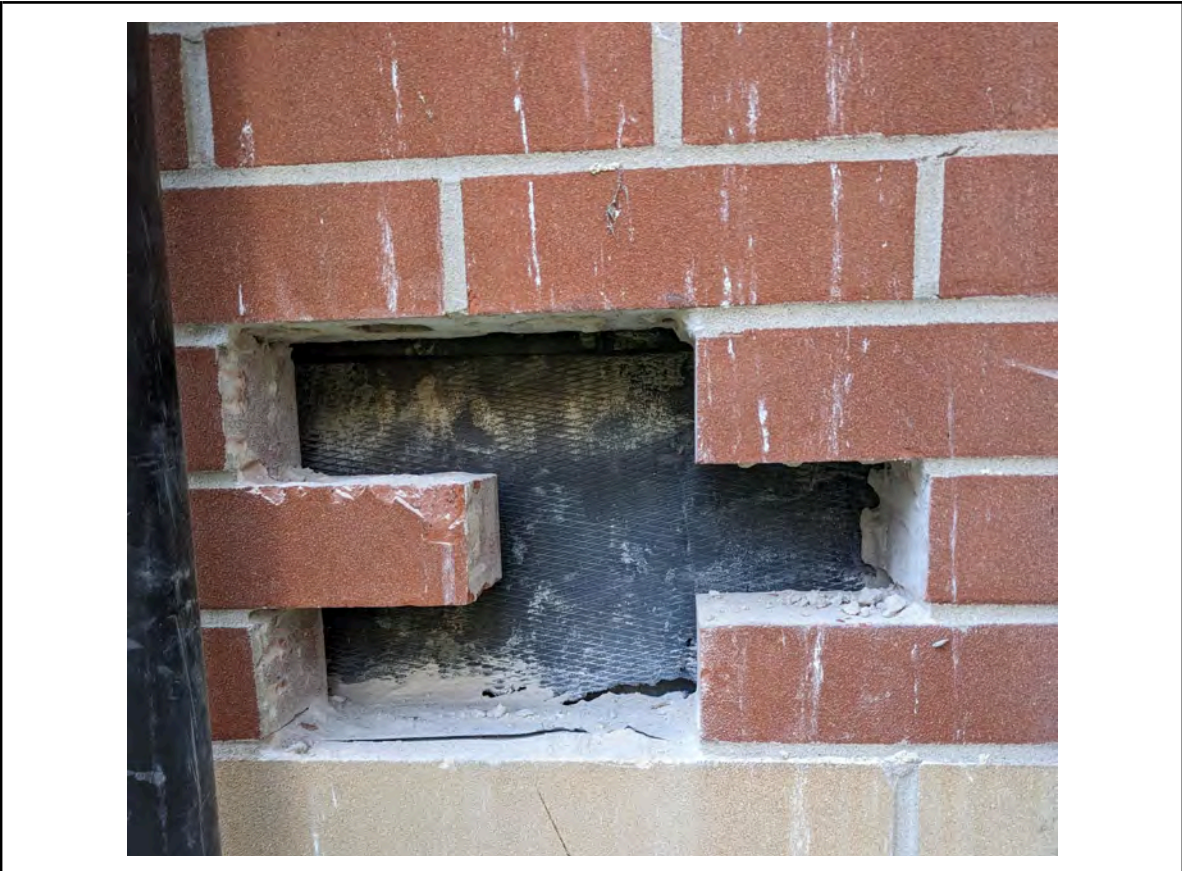
Photo 63: Location 30 - Brick removed at 1st floor at courtyard elevation
