35254 - Aura Court, 1 Percy Street, Manchester, Greater  
Manchester, M15 4AB

**Fire Risk Appraisal of the External Wall (FRAEW)**

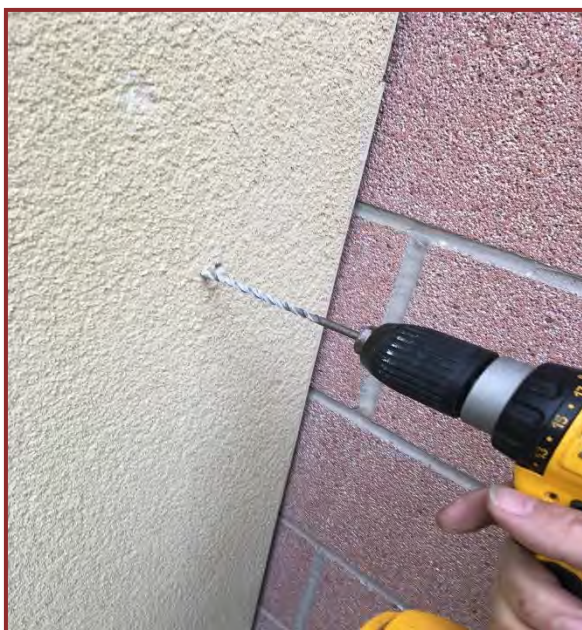
**Level** Ground Floor Rear Courtyard      **Location:** Render

**Area 2** covered the render areas within the rear courtyard. A drill test was carried out to demonstrate that the render was solid render 2 coat system onto a solid masonry substrate with no cavity. No combustible elements were found in the area checked. As there is no cavity within this render construction fire barriers are not required here.

Image showing the render drill test being performed. This render backed onto a solid masonry substrate, with no cavities. Therefore no fire barriers are required within this area.

**Area Two:** No recommendations – the render is of limited combustibility with no cavity.

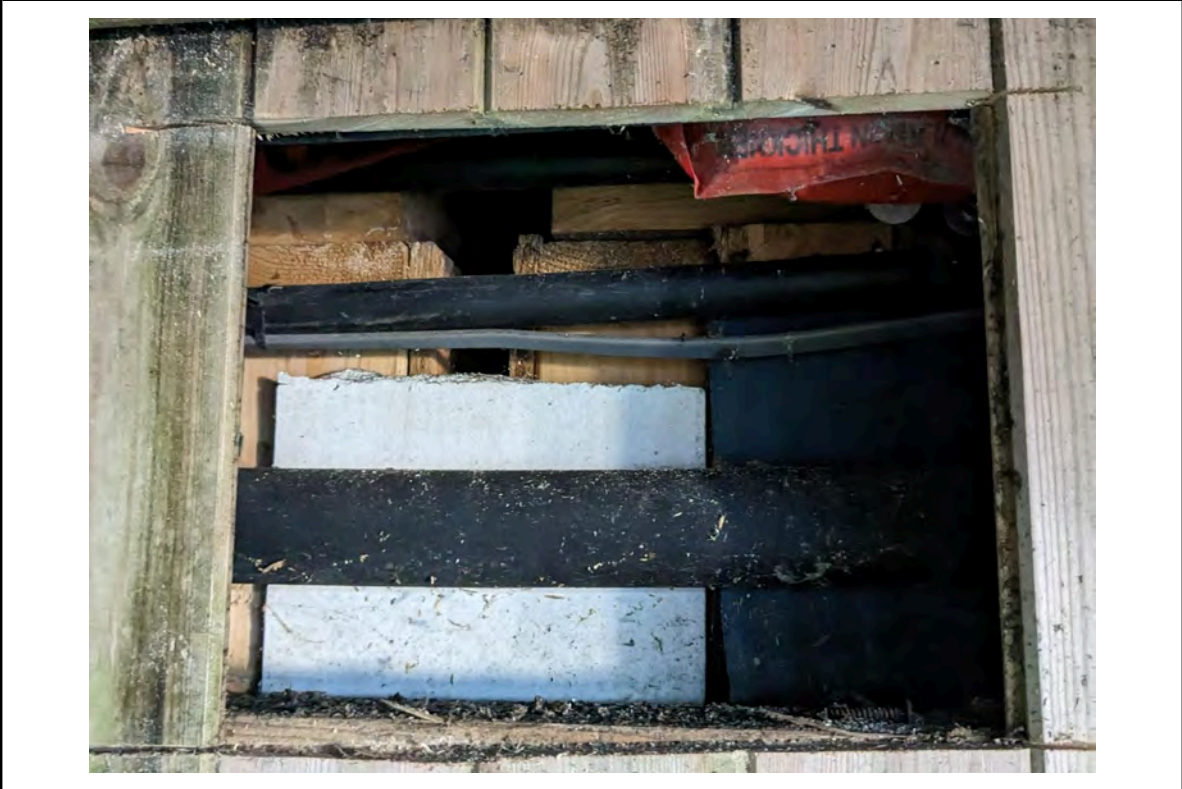
Photo 48: Location 22 - Timber cladding system build up

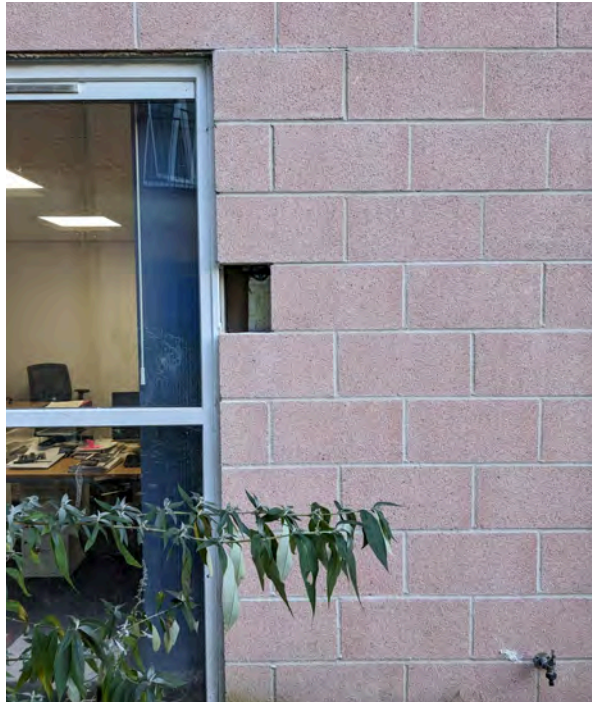
Photo 57: Location 27 - Artstone removed at ground floor at courtyard elevation

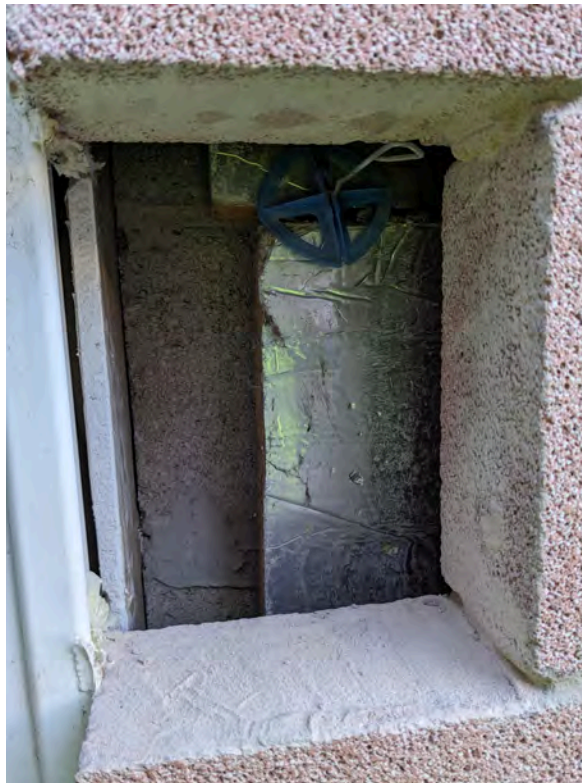
Photo 58: Location 27 - Artstone build up
